PERFORMANCE AUDIT REPORT ON INSTALLATION AND MAINTENANCE OF ROAD FURNITURE

KENYA NATIONAL HIGHWAYS AUTHORITY
KENYA URBAN ROADS AUTHORITY AND
THE KENYA RURAL ROADS AUTHORITY

NOVEMBER 2020

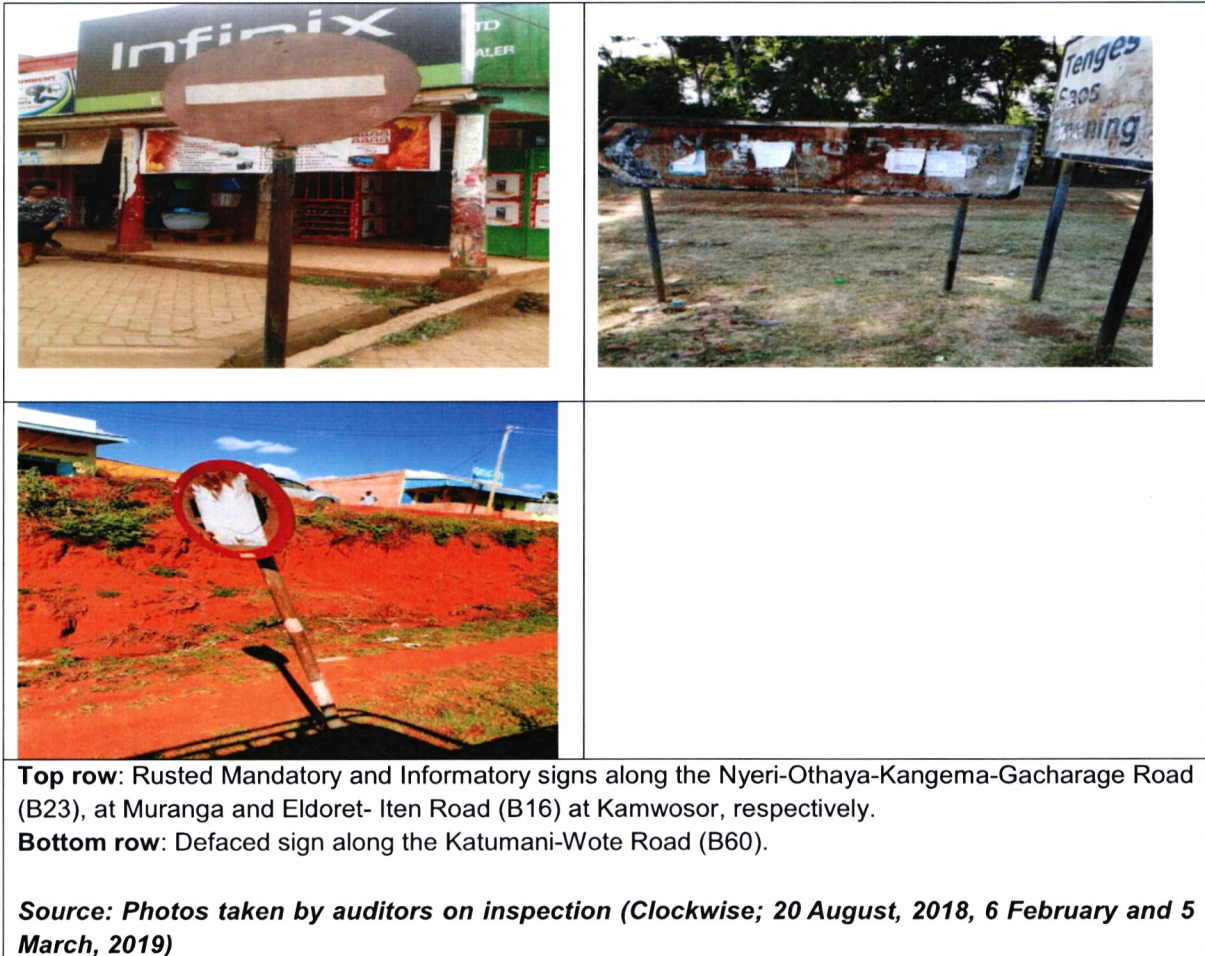
Figure 2: Road Signs that were Defaced, Faded and had Rust

4.14 **Figure 2** shows roads with road signs that were defaced, faded and had rust. These roads were under Performance-Based Contracts that were about to lapse;

- i. The Nyeri-Othaya-Kangema-Gacharage Road (B23), which had a defaced signage, faded road markings and damaged guardrails;

- ii. The Eldoret-Iten Road (B16) with damaged guardrails; and
- iii. The Katumani-Wote Road (B60) which had a defaced signage.

4.15 Minimal or lack of maintenance could be attributed to the fact that road furniture is not given priority during planning for maintenance. This is evident from the ARICS report reviewed that did not capture the condition of road furniture. This means that recommendations on aspects to be included in the work plans for maintenance may lack the necessary work to be carried out on road furniture. Consequently, maintenance may not be adequately done. Lack of maintenance of road furniture has direct and indirect cost as neglected road structures and signs may lead to road accidents.

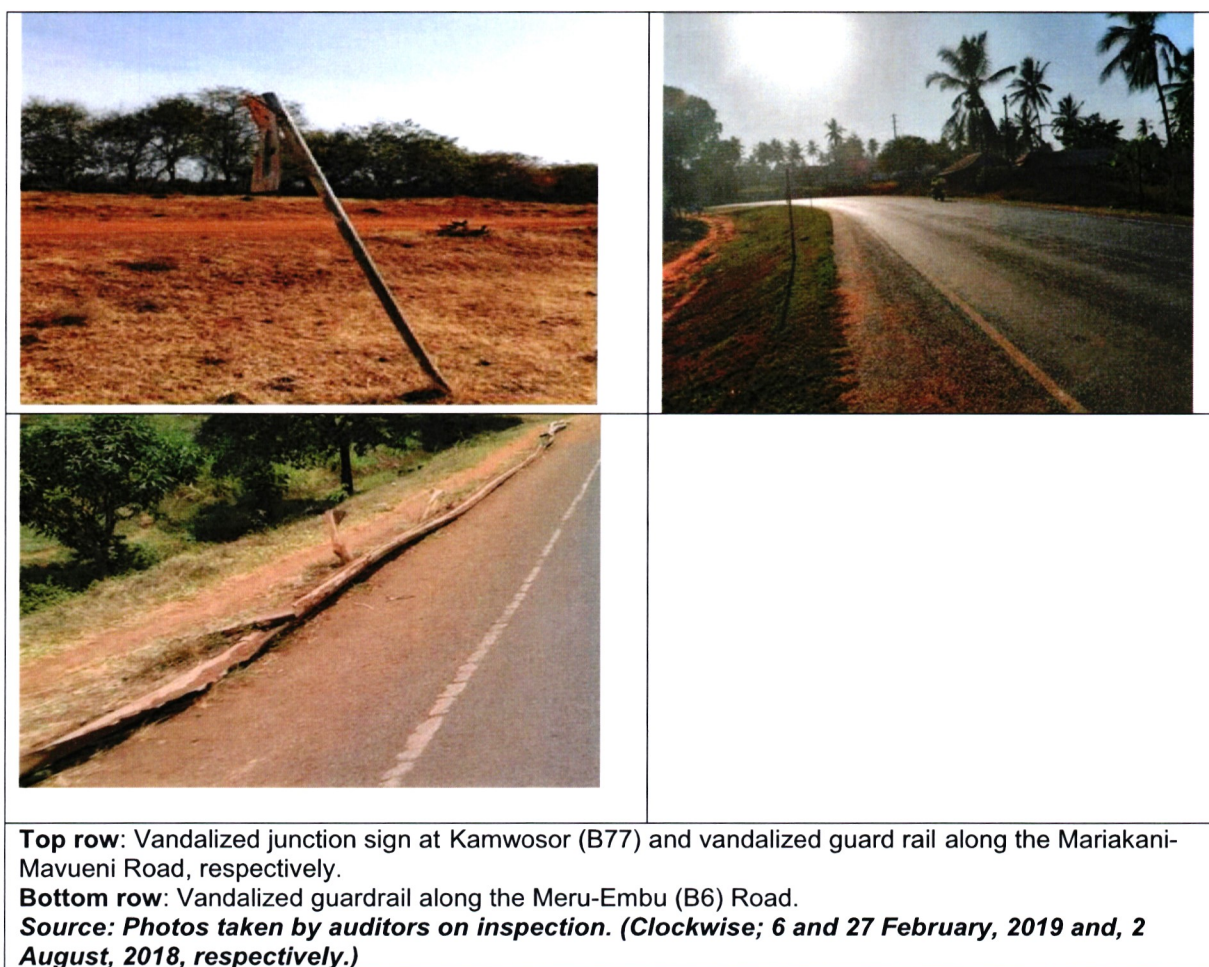
Figure 3: Vandalised Road Furniture

- 4.17 During field visits between January and March 2019, it was observed that there were cases of vandalism of road furniture on the roads inspected. In total, there were 50 vandalized road signs, 40 vandalized guardrails and 14 vandalized bridge rails on the 22 roads inspected. The Gilgil-Mau Summit Road (A8), Machakos-Kitui Road (B62) and Mariakani- Kaloleni- Mavueni Road (B91) are among the roads that had the greatest number of vandalized road furniture as shown on **Appendix 10** and in **Figure 3**.

- 4.18 The sustained vandalism of road furniture can be attributed to inadequate monitoring of road furniture and lack of mechanisms for reporting vandalism which would encourage the road users to promptly report vandalism. It was also noted that the material used for

roads signs, mostly metallic, are more susceptible to vandalism because of the relatively high market value of scrap metal. In addition, the Scrap Metal Act, enacted in 2015 to make provisions for the regulation of dealing in scrap metals had not been operationalised by the Ministry of Trade and Industry at the time of the audit.

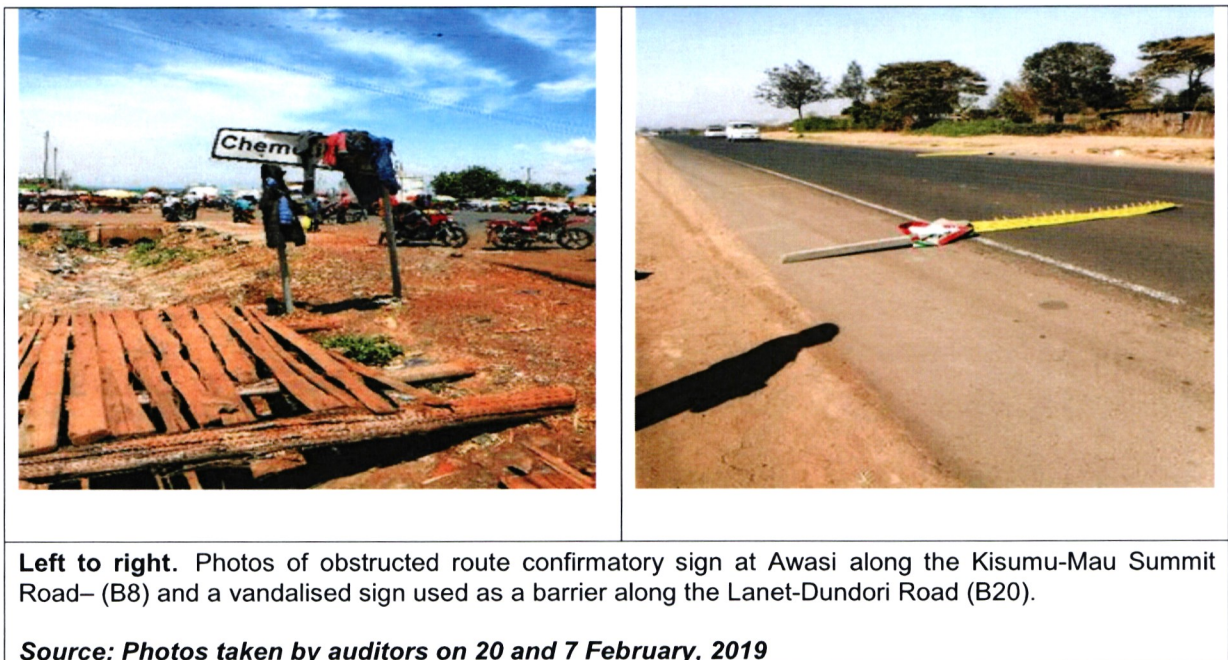
Figure 4: Inappropriate use of Road Furniture by the Public

- 4.19 Interviews conducted during the audit revealed that KeNHA does not carry out adequate sensitization campaigns to educate the public on the importance of protecting road furniture. The Regional Offices were allocated Ksh. 3 million every year for sensitisation and demarcation of road reserves. The officers interviewed revealed that a large proportion of this funding is mainly prioritised for demarcation of road reserves and sensitisation of the public. This is particularly in areas where the Authority is planning to demolish structures that are on road reserves. **Figure 4** shows inappropriate use of road furniture by the public.

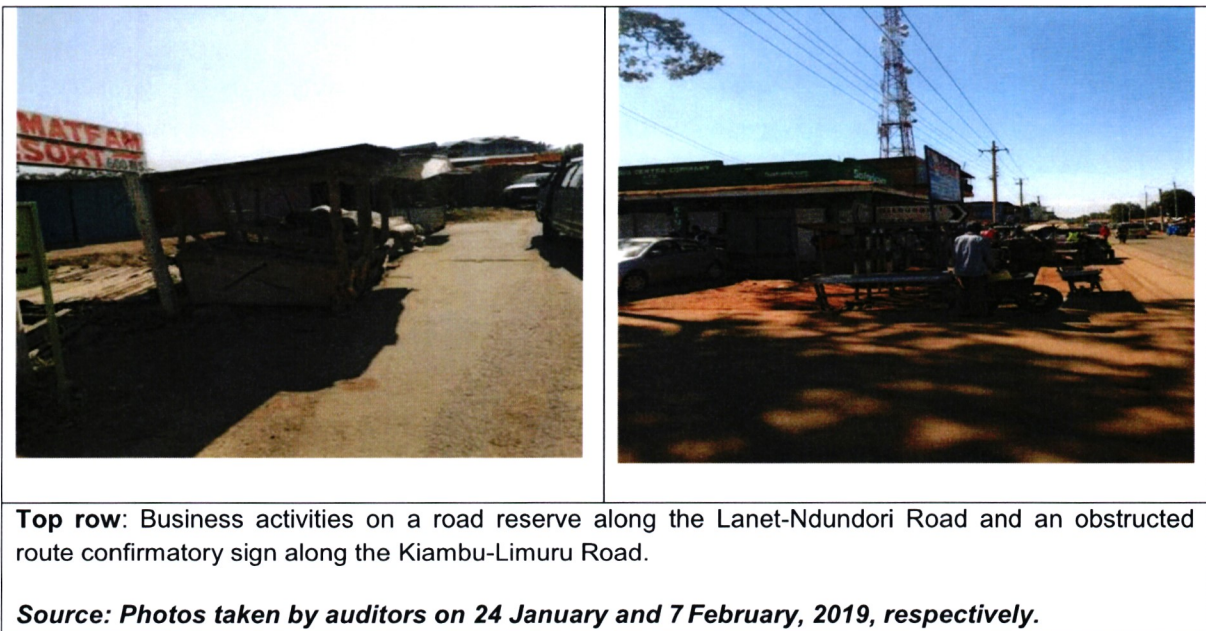
Figure 5: Encroachment along Roads

- 4.22 During the audit inspection between January and March 2019, it was observed that 10 out of 22 roads inspected were not demarcated. For instance, the Eldoret-Kapsabet Road (B8), Ekeru-Ebuyango Road (C781), Kiambu-Limuru Road (B32), Lanet-Ndundori Road (B20) and Mavueni-Sabasaba Road (A7) had been encroached with building structures, businesses and farming activities as depicted in **Figure 5**.

4.25 Encroachment results to blockage of drainages and obstruction of visibility of road signs, leading to serious compromise on road safety. Failure to collaborate with stakeholders leads to encroachment on road reserves as a result of conflict of interest among various agencies such as county governments.

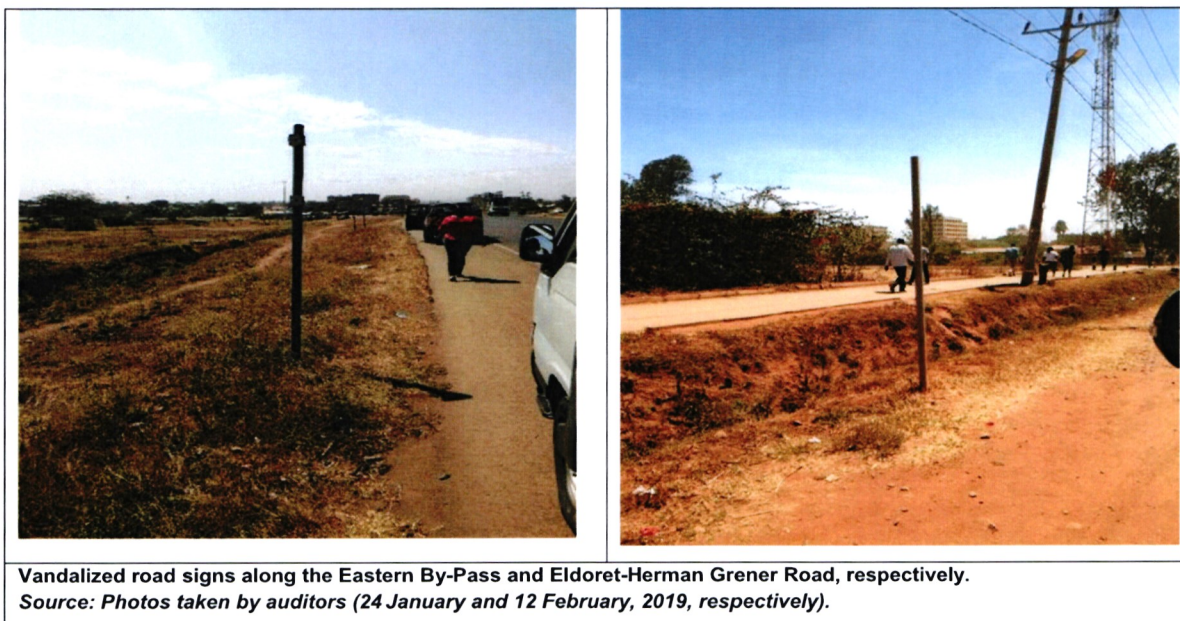
Figure 6: Vandalised Road Furniture

- 4.37 Road Furniture plays an important role in communicating important messages as well as protecting road users. They are important assets and as such should be protected from vandalism.
- 4.38 During field visits in January, February and March, 2019, it was observed that there were cases of vandalism of road signs on the roads inspected. Some of the roads that had vandalised road furniture are Eastern and Northern Bypass, Eldoret-Herman Greener School Road, Kisambai-Sabatia Road in Kakamega and Bangladesh-Baringo Road in Nakuru, among others. **Figure 6** shows photos of vandalised road furniture taken during the audit.

- 4.39 The sustained vandalism of road furniture can be attributed to lack of continuous inspection and monitoring of road furniture and lack of mechanisms for reporting vandalism. Reporting mechanisms would encourage road users to promptly report vandalism. It was also noted that the material used for road signs, mostly metallic, is more susceptible to vandalism because of the relatively high market value of scrap metal. In addition, the Scrap Metal Act, enacted in 2015 to make provisions for the regulation of dealing in scrap metals had not been operationalised by the Ministry of Trade and Industry at the time of the audit.

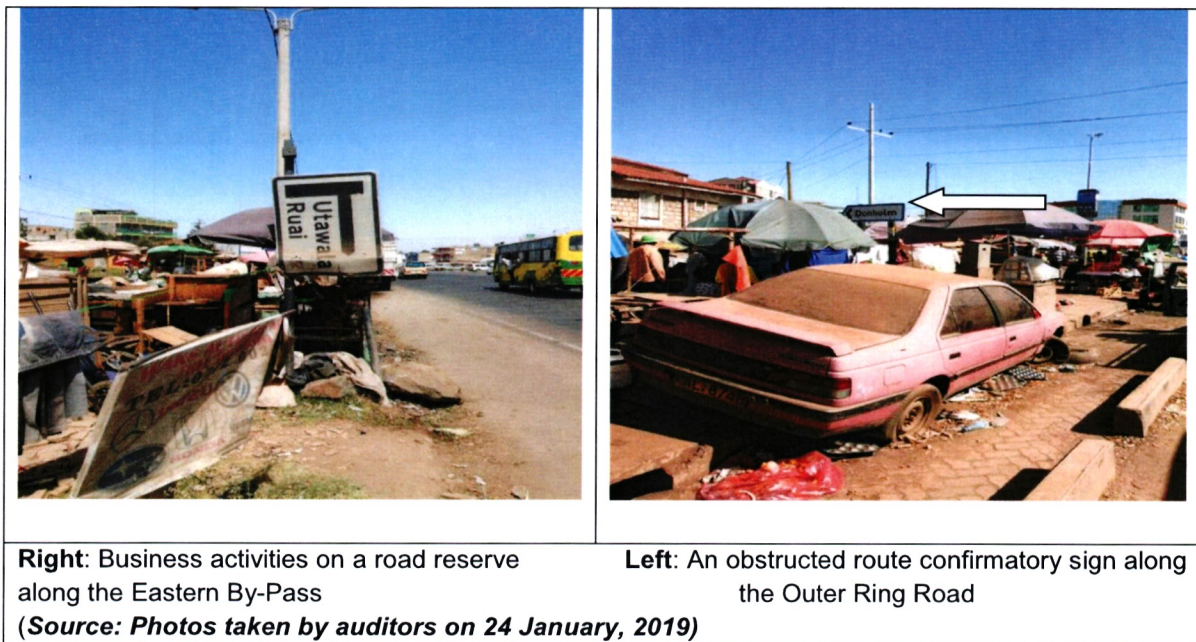
Figure 7: Encroachment on Roads

- 4.43 During the field inspection in February and March 2019, it was observed that all the KURA roads inspected, except for the Eastern Bypass, were not demarcated. It was also observed that 17 out of the 24 roads inspected were encroached. This is depicted in **Figure 7** and **Appendix 12**.

- 4.44 Encroachment results to blockage of drainages and obstruction of visibility of road signs, leading to serious compromise on road safety. Interviews with Regional Managers revealed that collaboration with stakeholders on roadside development activities was not adequate.

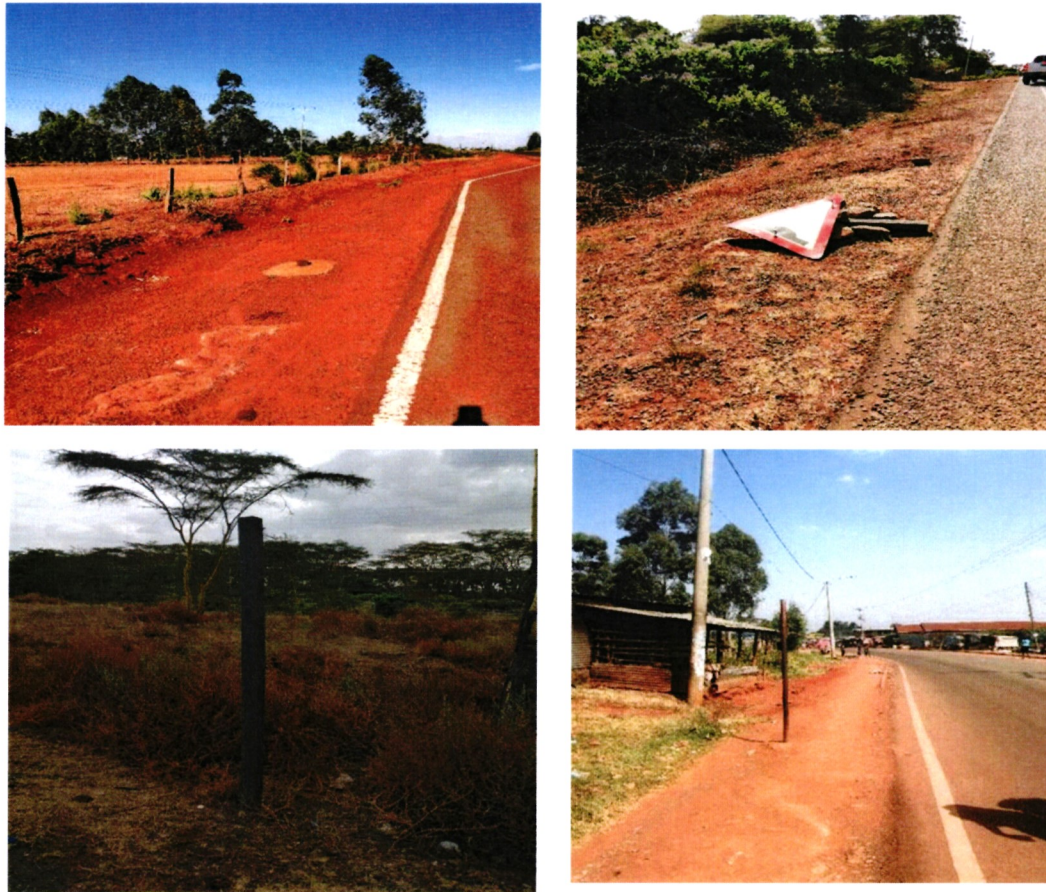
Figure 8: Vandalised Road Furniture

- 4.56 According to the Road Design Manual–Geometric Design for Rural Road Part 1, Chapter 3 (b); road signs and lighting supports and other utility poles should be located far enough from the carriageway to reduce the likelihood of being struck by out of control vehicles, or they should have break-way capability.
- 4.57 During field visits between January and March 2019, it was observed that there were cases of vandalism of road signs on the roads inspected. Some of the roads that had vandalised road furniture are Jua Kali-Sugoi Road, Marula-Kongoni Road, Kabiria Road and SGR-Mkupe Jetty Road among others as shown in **Figure 8**.

Top row: Vandalized road sign along the Jua Kali-Sugoi Road; Uasin Gishu County.

Bottom row: Vandalized road sign along the Marula-Kongoni Road in Nakuru County and Kabiria Road in Dagoretti South; Nairobi County.
