PERFORMANCE AUDIT REPORT ON INSTALLATION AND MAINTENANCE OF ROAD FURNITURE

KENYA NATIONAL HIGHWAYS AUTHORITY KENYA URBAN ROADS AUTHORITY AND THE KENYA RURAL ROADS AUTHORITY

NOVEMBER 2020

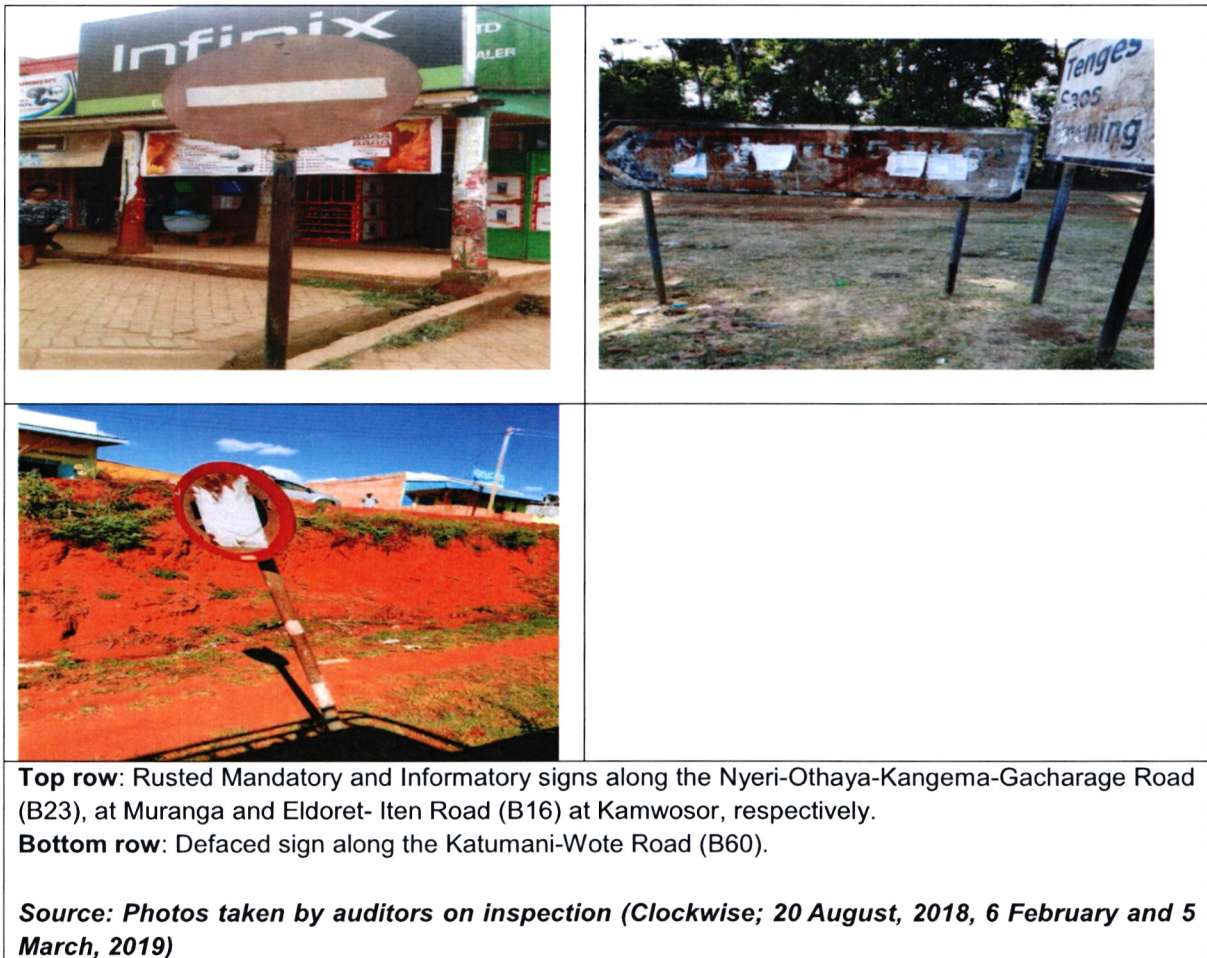
Figure 2: Road Signs that were Defaced, Faded and had Rust

4.14 **Figure 2** shows roads with road signs that were defaced, faded and had rust. These roads were under Performance-Based Contracts that were about to lapse;

- i. The Nyeri-Othaya-Kangema-Gacharage Road (B23), which had a defaced signage, faded road markings and damaged guardrails;

- ii. The Eldoret-Iten Road (B16) with damaged guardrails; and
- iii. The Katumani-Wote Road (B60) which had a defaced signage.

4.15 Minimal or lack of maintenance could be attributed to the fact that road furniture is not given priority during planning for maintenance. This is evident from the ARICS report reviewed that did not capture the condition of road furniture. This means that recommendations on aspects to be included in the work plans for maintenance may lack the necessary work to be carried out on road furniture. Consequently, maintenance may not be adequately done. Lack of maintenance of road furniture has direct and indirect cost as neglected road structures and signs may lead to road accidents.

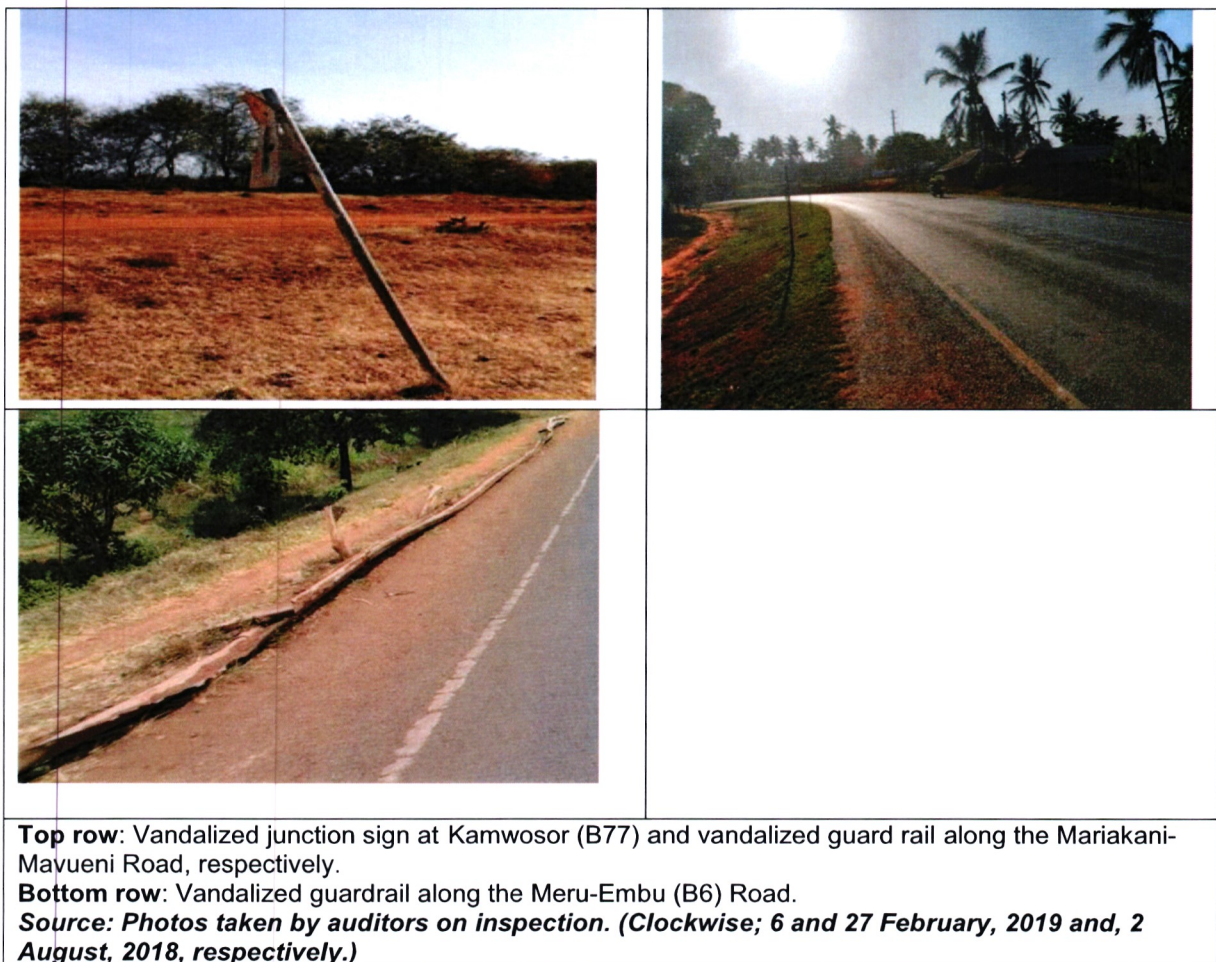
Figure 3: Vandalised Road Furniture

- 4.17 During field visits between January and March 2019, it was observed that there were cases of vandalism of road furniture on the roads inspected. In total, there were 50 vandalized road signs, 40 vandalized guardrails and 14 vandalized bridge rails on the 22 roads inspected. The Gilgil-Mau Summit Road (A8), Machakos-Kitui Road (B62) and Mariakani- Kaloleni- Mavueni Road (B91) are among the roads that had the greatest number of vandalized road furniture as shown on **Appendix 10** and in **Figure 3**.

- 4.18 The sustained vandalism of road furniture can be attributed to inadequate monitoring of road furniture and lack of mechanisms for reporting vandalism which would encourage the road users to promptly report vandalism. It was also noted that the material used for

roads signs, mostly metallic, are more susceptible to vandalism because of the relatively high market value of scrap metal. In addition, the Scrap Metal Act, enacted in 2015 to make provisions for the regulation of dealing in scrap metals had not been operationalised by the Ministry of Trade and Industry at the time of the audit.

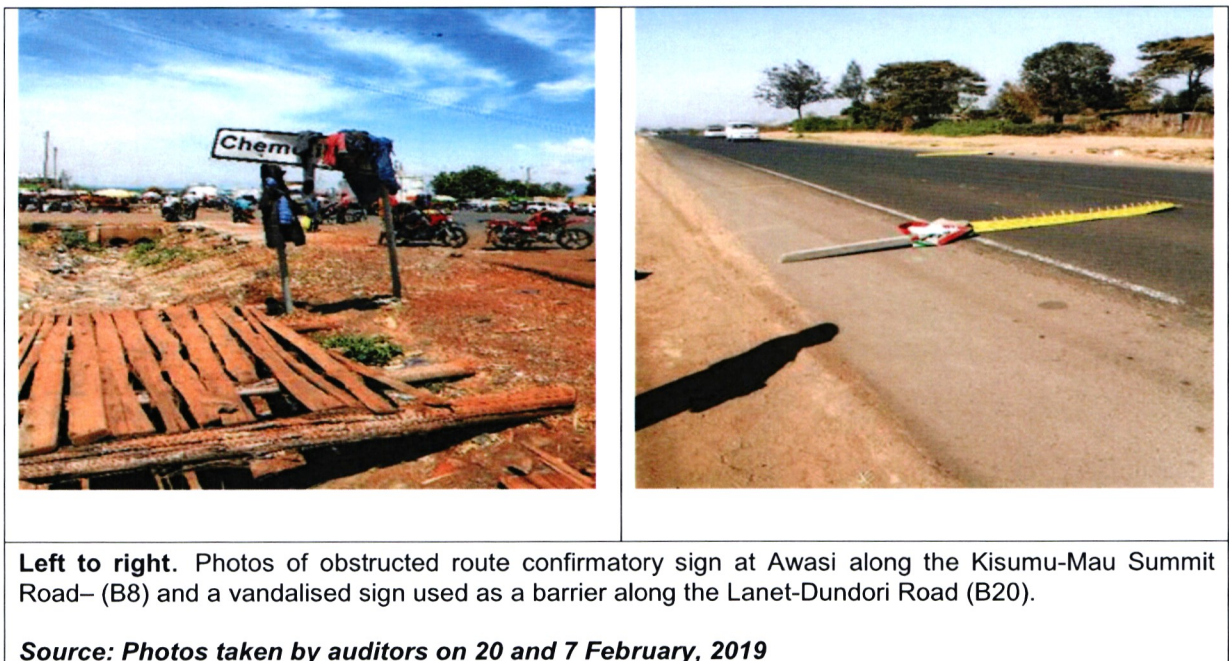
Figure 4: Inappropriate use of Road Furniture by the Public

- 4.19 Interviews conducted during the audit revealed that KeNHA does not carry out adequate sensitization campaigns to educate the public on the importance of protecting road furniture. The Regional Offices were allocated Ksh. 3 million every year for sensitisation and demarcation of road reserves. The officers interviewed revealed that a large proportion of this funding is mainly prioritised for demarcation of road reserves and sensitisation of the public. This is particularly in areas where the Authority is planning to demolish structures that are on road reserves. **Figure 4** shows inappropriate use of road furniture by the public.

- 4.20 Warning and informatory signs communicate to road users and reduce the risk of accidents. Vandalism therefore may increase instances of road accidents due to misinformation and limited or no protection to road users.

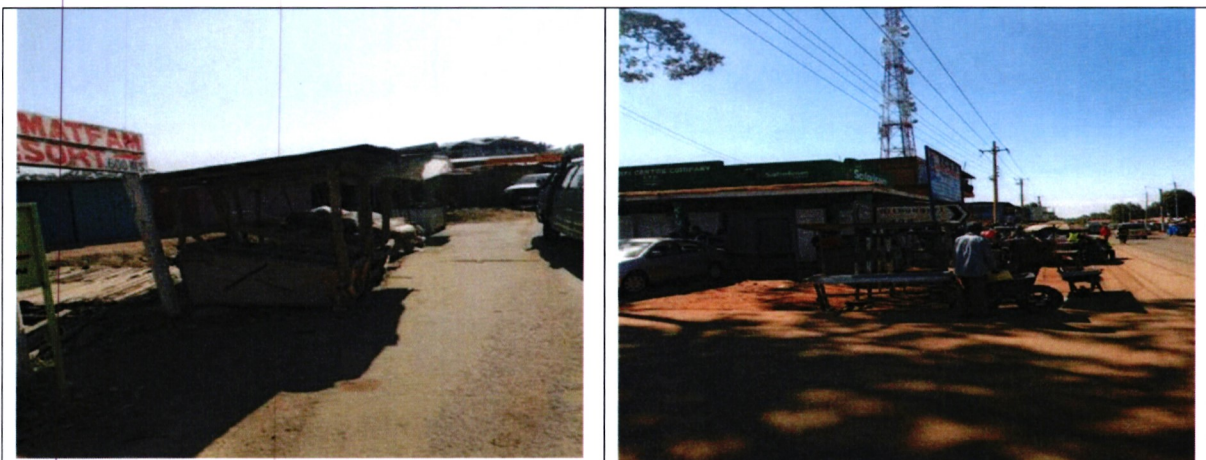
Figure 5: Encroachment along Roads

- 4.22 During the audit inspection between January and March 2019, it was observed that 10 out of 22 roads inspected were not demarcated. For instance, the Eldoret-Kapsabet Road (B8), Ekeru-Ebuyango Road (C781), Kiambu-Limuru Road (B32), Lanet-Ndundori Road (B20) and Mavueni-Sabasaba Road (A7) had been encroached with building structures, businesses and farming activities as depicted in **Figure 5**.

Top row: Business activities on a road reserve along the Lanet-Ndundori Road and an obstructed route confirmatory sign along the Kiambu-Limuru Road.

- 4.25 Encroachment results to blockage of drainages and obstruction of visibility of road signs, leading to serious compromise on road safety. Failure to collaborate with stakeholders leads to encroachment on road reserves as a result of conflict of interest among various agencies such as county governments.

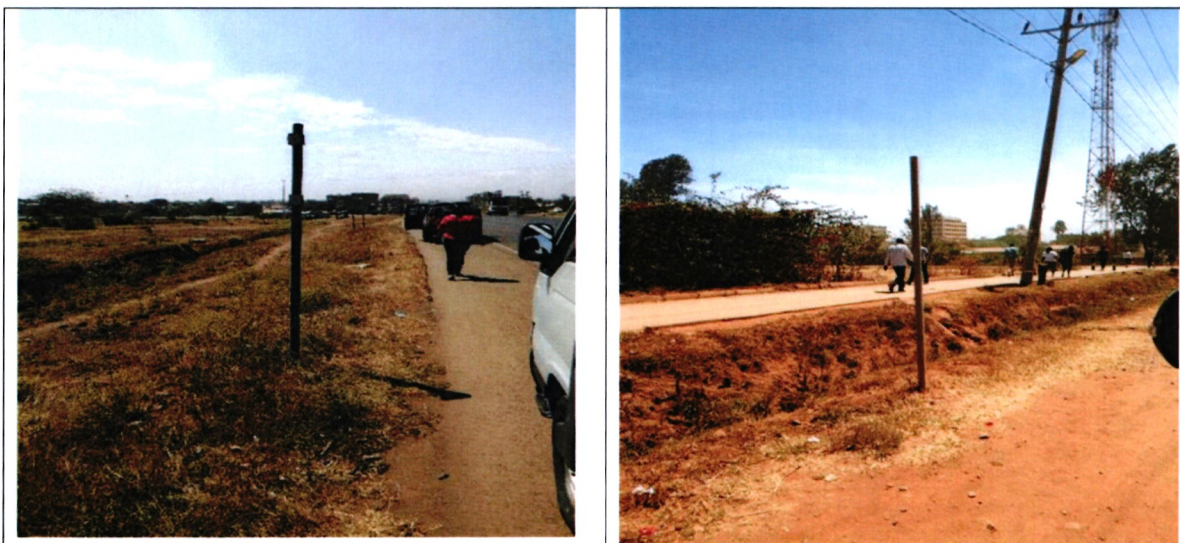
Figure 6: Vandalised Road Furniture

- 4.37 Road Furniture plays an important role in communicating important messages as well as protecting road users. They are important assets and as such should be protected from vandalism.
- 4.38 During field visits in January, February and March, 2019, it was observed that there were cases of vandalism of road signs on the roads inspected. Some of the roads that had vandalised road furniture are Eastern and Northern Bypass, Eldoret-Herman Greener School Road, Kisambai-Sabatia Road in Kakamega and Bangladesh-Baringo Road in Nakuru, among others. **Figure 6** shows photos of vandalised road furniture taken during the audit.

Vandalized road signs along the Eastern By-Pass and Eldoret-Herman Grener Road, respectively.
Source: Photos taken by auditors (24 January and 12 February, 2019, respectively).

- 4.39 The sustained vandalism of road furniture can be attributed to lack of continuous inspection and monitoring of road furniture and lack of mechanisms for reporting vandalism. Reporting mechanisms would encourage road users to promptly report vandalism. It was also noted that the material used for road signs, mostly metallic, is more susceptible to vandalism because of the relatively high market value of scrap metal. In addition, the Scrap Metal Act, enacted in 2015 to make provisions for the regulation of dealing in scrap metals had not been operationalised by the Ministry of Trade and Industry at the time of the audit.

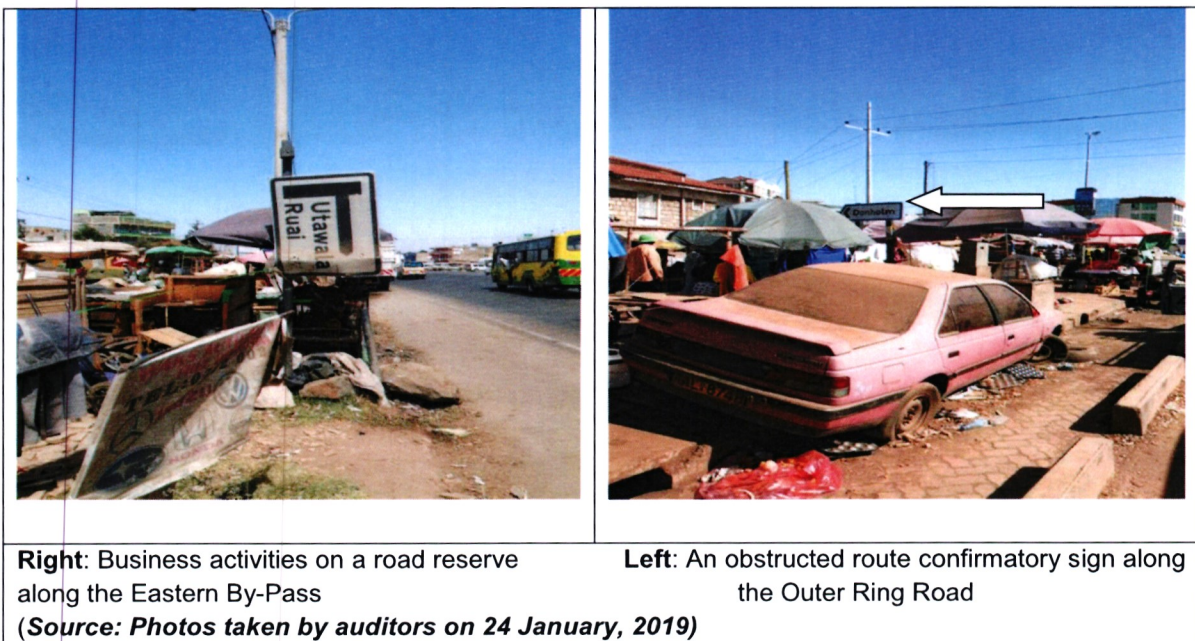
Figure 7: Encroachment on Roads

- 4.43 During the field inspection in February and March 2019, it was observed that all the KURA roads inspected, except for the Eastern Bypass, were not demarcated. It was also observed that 17 out of the 24 roads inspected were encroached. This is depicted in **Figure 7** and **Appendix 12**.

- 4.44 Encroachment results to blockage of drainages and obstruction of visibility of road signs, leading to serious compromise on road safety. Interviews with Regional Managers revealed that collaboration with stakeholders on roadside development activities was not adequate.

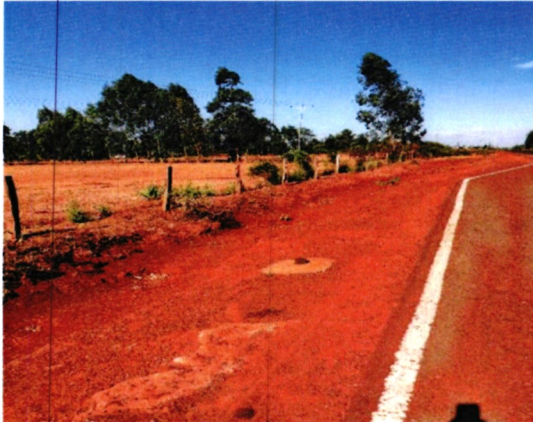
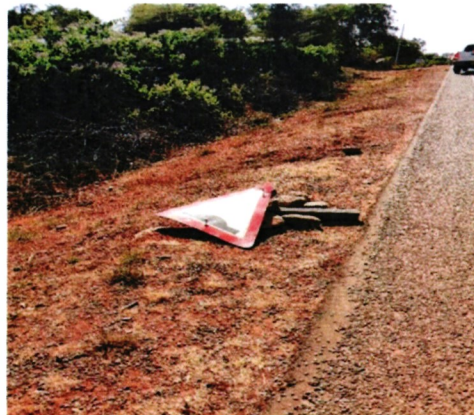
Figure 8: Vandalised Road Furniture

- 4.56 According to the Road Design Manual–Geometric Design for Rural Road Part 1, Chapter 3 (b); road signs and lighting supports and other utility poles should be located far enough from the carriageway to reduce the likelihood of being struck by out of control vehicles, or they should have break-way capability.
- 4.57 During field visits between January and March 2019, it was observed that there were cases of vandalism of road signs on the roads inspected. Some of the roads that had vandalised road furniture are Jua Kali-Sugoi Road, Marula-Kongoni Road, Kabiria Road and SGR-Mkupe Jetty Road among others as shown in **Figure 8**.

Top row: Vandalized road sign along the Jua Kali-Sugoi Road; Uasin Gishu County.

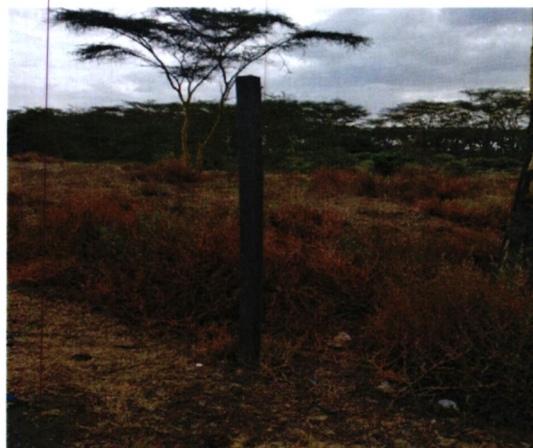
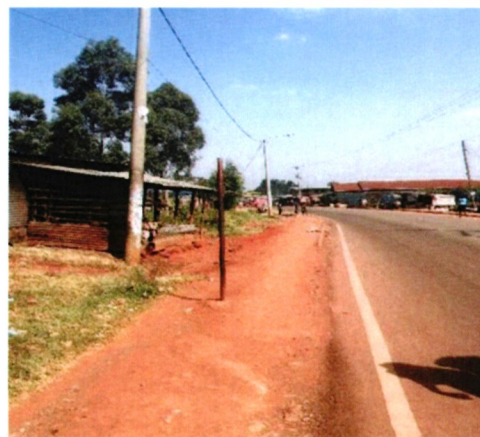
Bottom row: Vandalized road sign along the Marula-Kongoni Road in Nakuru County and Kabiria Road in Dagoretti South; Nairobi County.
