PARLIAMENT  
OF KENYA  
LIBRARY

SEPTEMBER 2023

I am pleased to present this performance audit report on: Conservation of Water Towers in Kenya by the Kenya Water Towers Agency. My Office carried out the audit under the mandate conferred to me by Article 229 (6) of the Constitution of Kenya, 2010, to confirm whether or not public money has been applied lawfully and in an effective way. In addition, Section 36 of the Public Audit Act, 2015 requires the Auditor-General to examine the economy, efficiency and effectiveness with which public money has been expended.

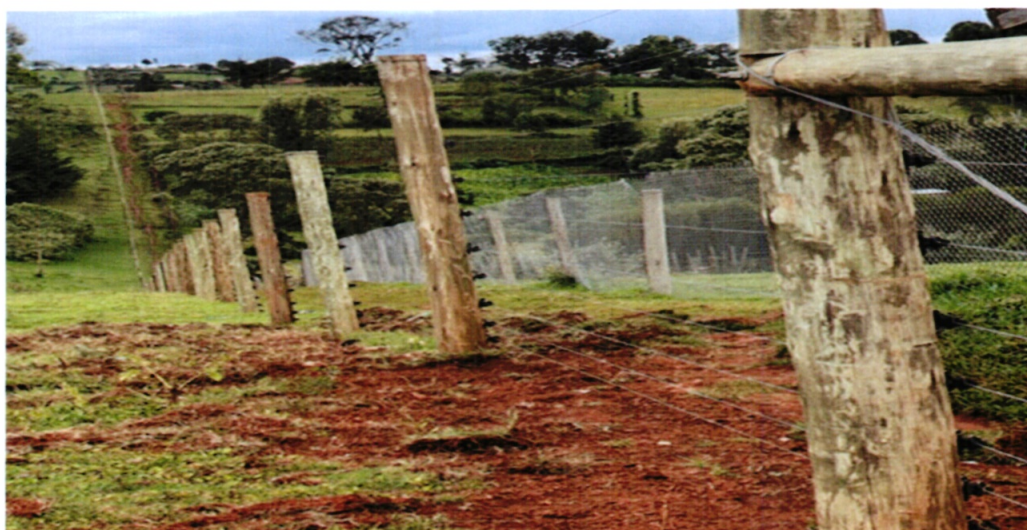
**Picture 1: Erected Boundary Fence Along Maasai Mau**

- 4.6 According to the Maasai Mau Phase II Action Plan, the Agency had targeted to construct an electric smart fence along the Maasai Mau Block covering the entire 119km boundary within two (2) years, starting from August 2019. However, only 30km of the fence had been constructed as at the time of audit in 2022. The fence was to provide a barrier for uncontrolled human access and real time monitoring of activities along the fence. The constructed fence observed during the audit inspection was as shown in **Picture 1**.

- 4.7 The lack of mapping and demarcation of boundaries exposed water towers to destructive human activities, especially encroachment. Interviews and document reviews revealed that all the sampled nine (9) water towers had land outside the protected forest area ranging from 47% to 100% as shown in **Table 3**.

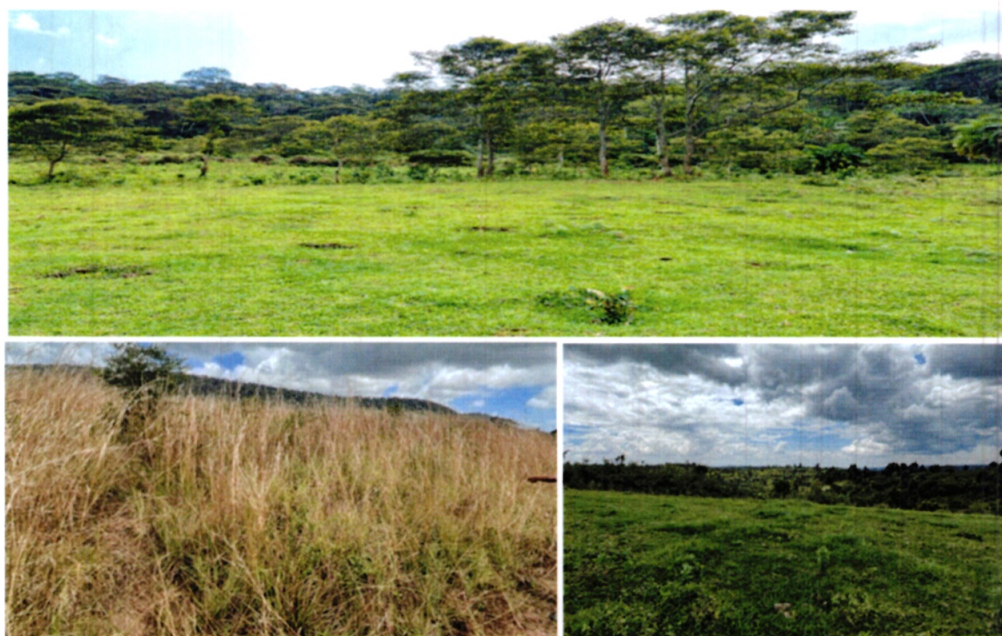
**Picture 2: Status of Reforested Sites in Nyambene, Shimba Hills and Maasai Mau**

- 4.44 Further, document review revealed that the Agency's recommended seedling survival rate was 80% for a reforestation intervention to be considered successful. However, review of seedling audit reports availed for audit revealed that five (5) out of the seven (7) planted sites recorded survival rates lower than 80% as shown in **Table 7**. This is despite the Agency spending approximately Ksh.174million on tree planting activities towards the 10% National Tree Cover Campaign during the period 2019/2020 to 2021/2022. For instance, out of the seven (7) sites whose seedling audit reports were availed for audit, only two (2) had a survival rate of 80% and above. Block 67 in Maasai Mau recorded a very low survival rate of 39.4%.

- 4.45 The low seedling survival rates in reforested areas were also observed during audit inspection. For example, patches of bare land were observed in sites that the Agency claimed to have reforested in Nyambene Hills, Shimba Hills and Maasai Mau forest as shown in **Picture 2**.

- 4.46 The Due to limited coverage of areas that required reforestation and low seedling survival rates, water towers were still under high levels of degradation, despite the Agency's rehabilitation efforts. Interviews and review of documents revealed a decline in water flow volumes attributed to the high degradation status in water towers.
- 4.47 The audit attributed the inadequate reforestation of degraded sites to lack of documented guidelines on tree planting in water towers in general. This resulted to a number of factors which affected reforestation activities, namely:
- i) Low seedling production;
  - ii) Challenges with procurement of seedlings;
  - iii) Lack of securing of rehabilitated sites; and
  - iv) Failure to weed reforested sites.

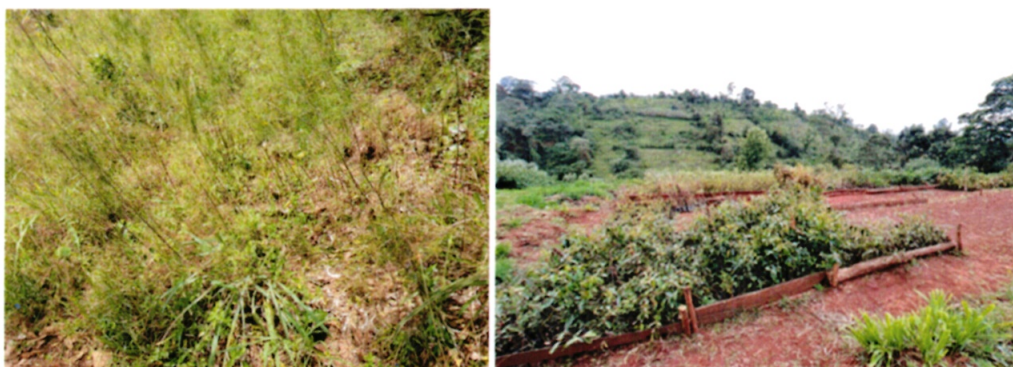
**Picture 3: Status of Community Owned Nurseries**

- 4.50 Interviews and document review revealed that the suppliers engaged by the Agency sourced seedlings far from the sites being rehabilitated. The seedlings were not given time to acclimatize with the area before planting, hence leading to low survival rate of the planted seedlings. Interviews and document review also revealed that the recommended height of a seedling should be between 1ft and 1.5ft. However, interviews with staff of the Agency and review of documents revealed that the seedlings delivered were often below the recommended height. In addition, review of documents revealed that seedlings were sometimes delivered either when the rains were about to subside or after the rainy season, hence could not survive without watering.

- 4.51 The audit noted that the Agency had started promoting local level seedling production by supporting selected community groups with tree nursery implements, including seeds. The arrangement was that the groups should produce seedlings and sell them to the Agency at a subsidised price. The seedlings were to be used for rehabilitation in the neighbouring water towers. However, physical verifications of such nurseries revealed low production capacity and poor nursery management. Besides, the seedlings looked overgrown as shown in **Picture 3** yet the Agency was supposed to procure from the community once the seedlings are mature. The groups reported that other than nursery implements, the Agency did not provide them with training on tree nursery management.

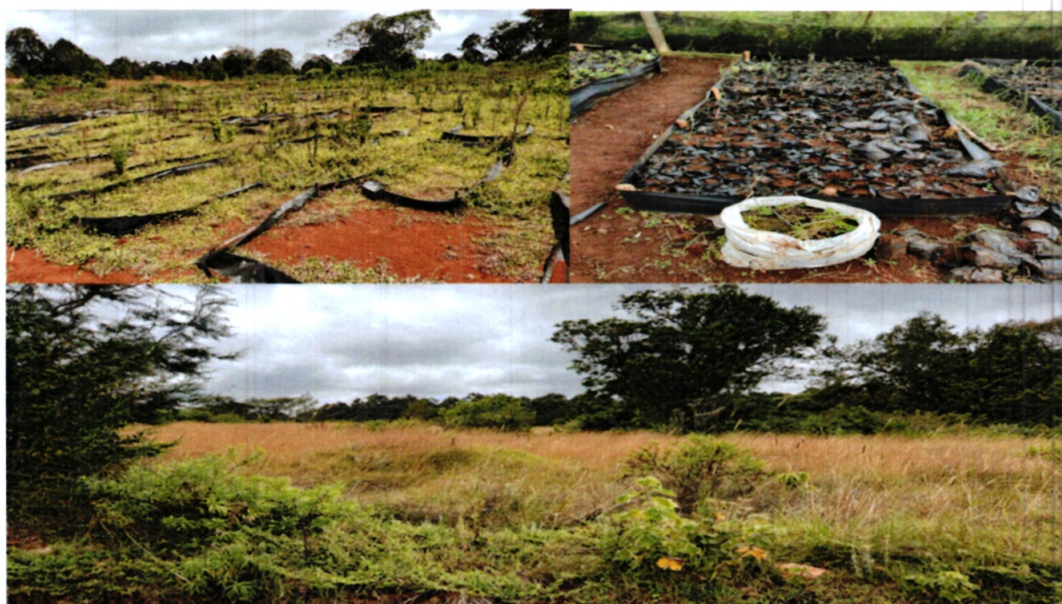
**Picture 4: The Status of the National Bamboo Demonstration Centre**

4.56 The audit revealed that the Agency spent approximately Ksh.147.7million during the period 2017/2018 to 2021/2022 towards establishment of bamboo enterprise. This involved establishment of a National Bamboo Growing Demonstration Centre at Kaptagat Forest, Elgeyo Hills, among other activities. The site was to act as a bamboo demonstration centre where interested individuals would learn about the commercial value of bamboo and also procure bamboo seedlings. However, physical verification revealed that the site had been neglected as shown in **Picture 4**. Therefore, the intended objective of providing an alternative livelihood through bamboo commercialization was not achieved.

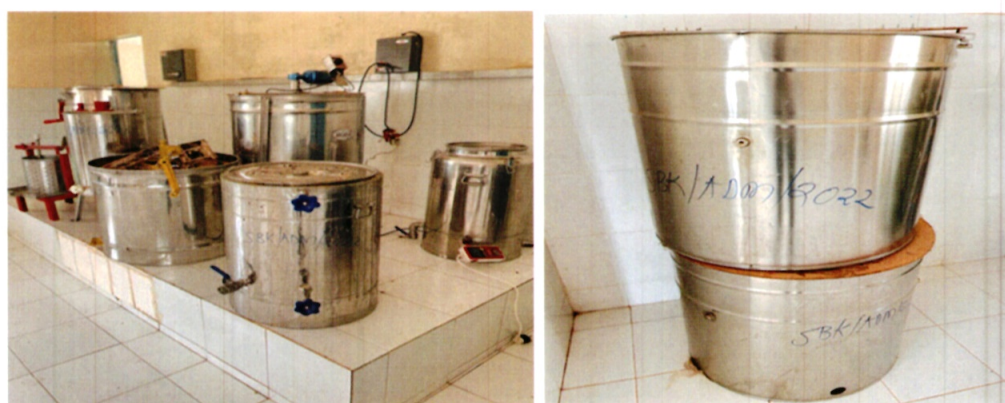
**Picture 5: Samburu Bee Keepers Honey Processing Factory**

- 4.60 The audit revealed that out of the eight (8) groups verified, only Samburu Bee Keepers had set up a honey processing factory as shown in **Picture 5**. However, interactions with group officials revealed the Agency provided a manual centrifuge, yet the honey produced in the region was highly viscous, requiring heating during processing. Consequently, the group did not use the equipment and resorted to use the equipment supplied to them later by the World Vision.

*Left photo- Honey processing factory setup; Right photo- manual centrifuges*

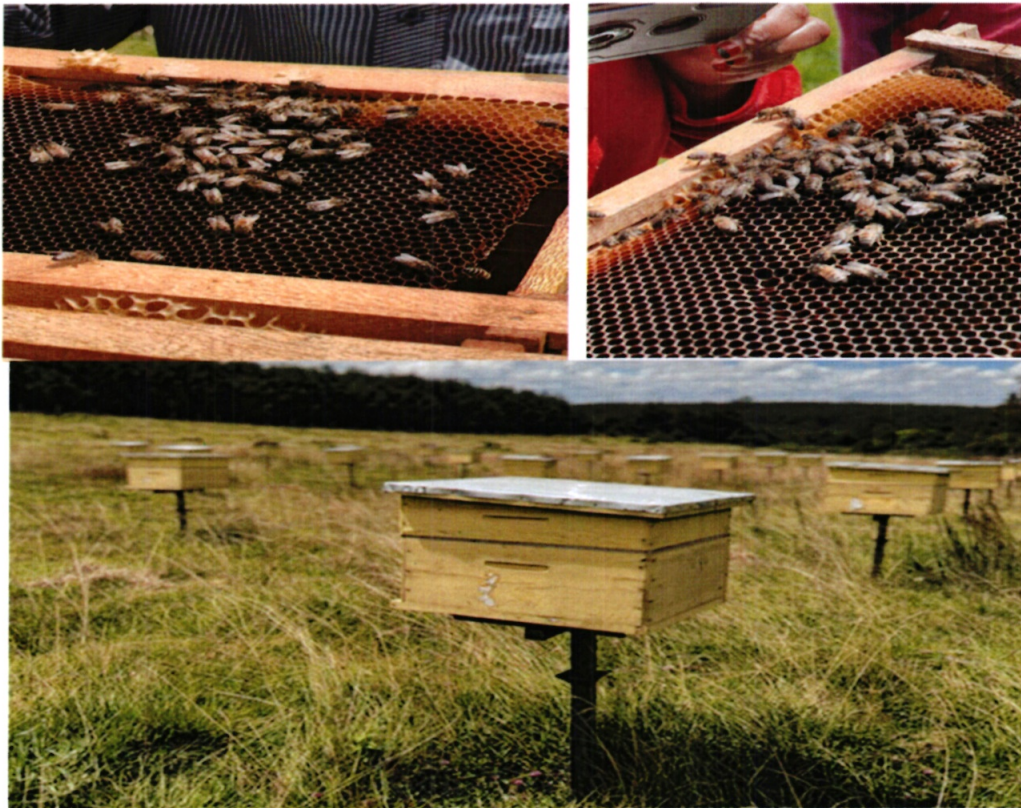
**Picture 6: Status of Beehives in Kiptunga Forest Apiary**

- 4.61 Some of the challenges affecting colonisation included pest infestation. In addition, physical verifications revealed that beneficiary groups lacked skills on apiary management and location of the apiaries. For example, physical verifications revealed that the beehives issued to a community group in Kiptunga Forest were initially colonised but got infested by insects. It was observed that although the beehive stands had provision for putting oil to deter insects, the group had not placed oil on the stands. The group had also located its apiary in an open area. Besides, the apiary had overgrown grass through which insects could easily access the beehives. Status of beehives in Kiptunga Forest were as shown in **Picture 6**
