**COMMISSION OF INQUIRY INTO THE ACCIDENT  
INVOLVING AIRCRAFT REGISTRATION 5Y-CDT**

**TYPE AS 350 B3e**

**COMMISSION OF INQUIRY INTO THE ACCIDENT INVOLVING  
AIRCRAFT REGISTRATION 5Y-CDT, TYPE AS350 B3e**

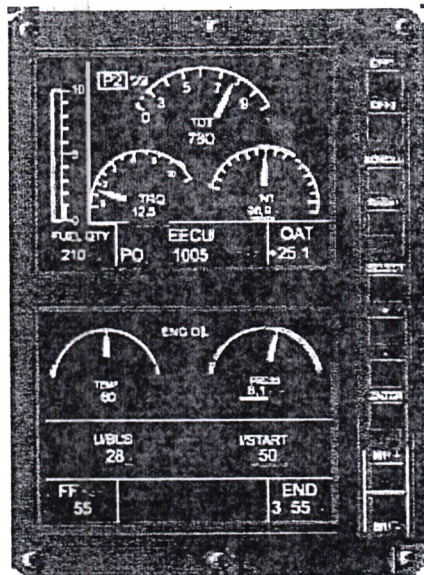
**Figure 3: VEMD**

able The aircraft is equipped with an electronic Vehicle and Engine Multifunction  
Display (VEMD) which displays aircraft and engine system status and  
ty of highlights any defect on a screen in the cockpit. It is this system that was  
the reported by the Eurocopter South Africa Maintenance Engineer (CW 50) to have  
gine displayed the defect of the EECU on the 31<sup>st</sup> May 2012 and defect of EDR on 7<sup>th</sup>  
June 2012 after the replacement of the EECU. It is noted that the unit fitted on

5<sup>th</sup> December 2011 in South Africa was a prototype (pre-certificated) unit which was fitted without the knowledge of the Commandant (CW 49) and the Chief Engineer KPAW.(CW 19).

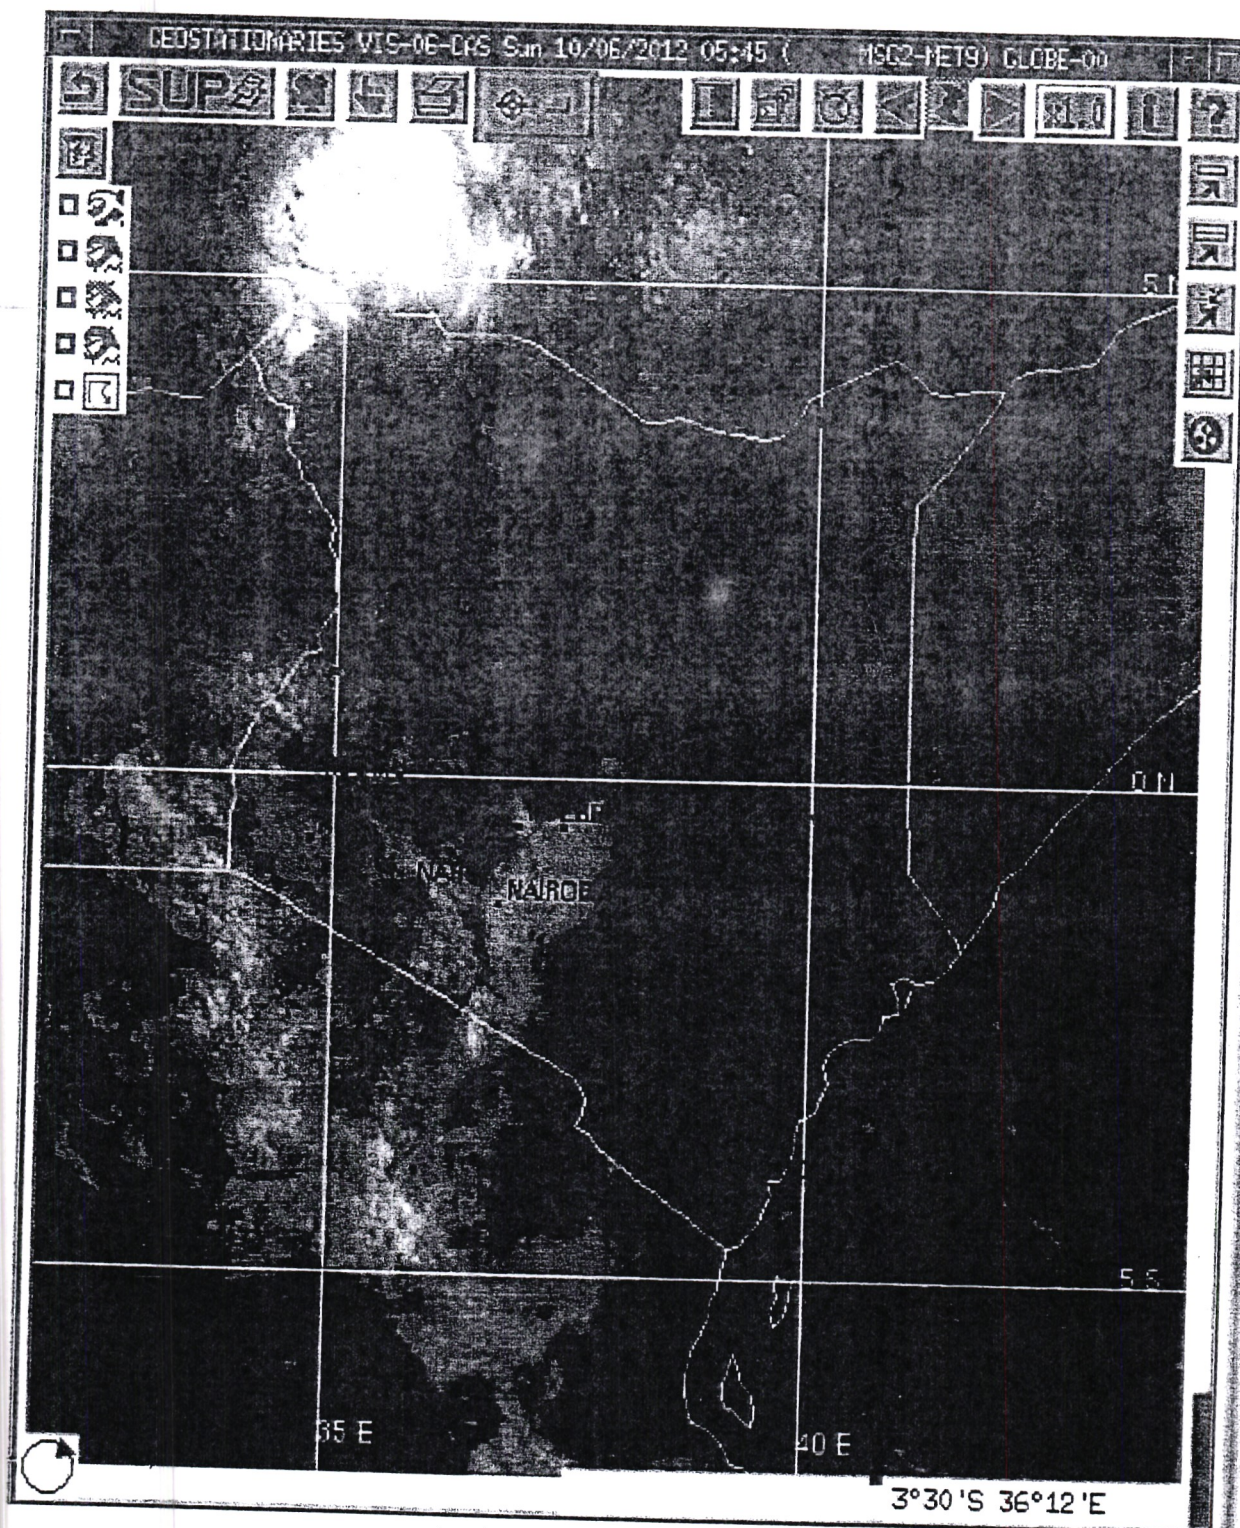
Satellite imagery from the visible channel taken at 0845 local time (Fig 10) produced by CW 57 indicated shallow low level clouds along the intended route was consistent with the imagery from the infra-red channel exhibited to the Commission.

**Figure 10: Satellite imagery from the visible channel taken at 0845 local time**

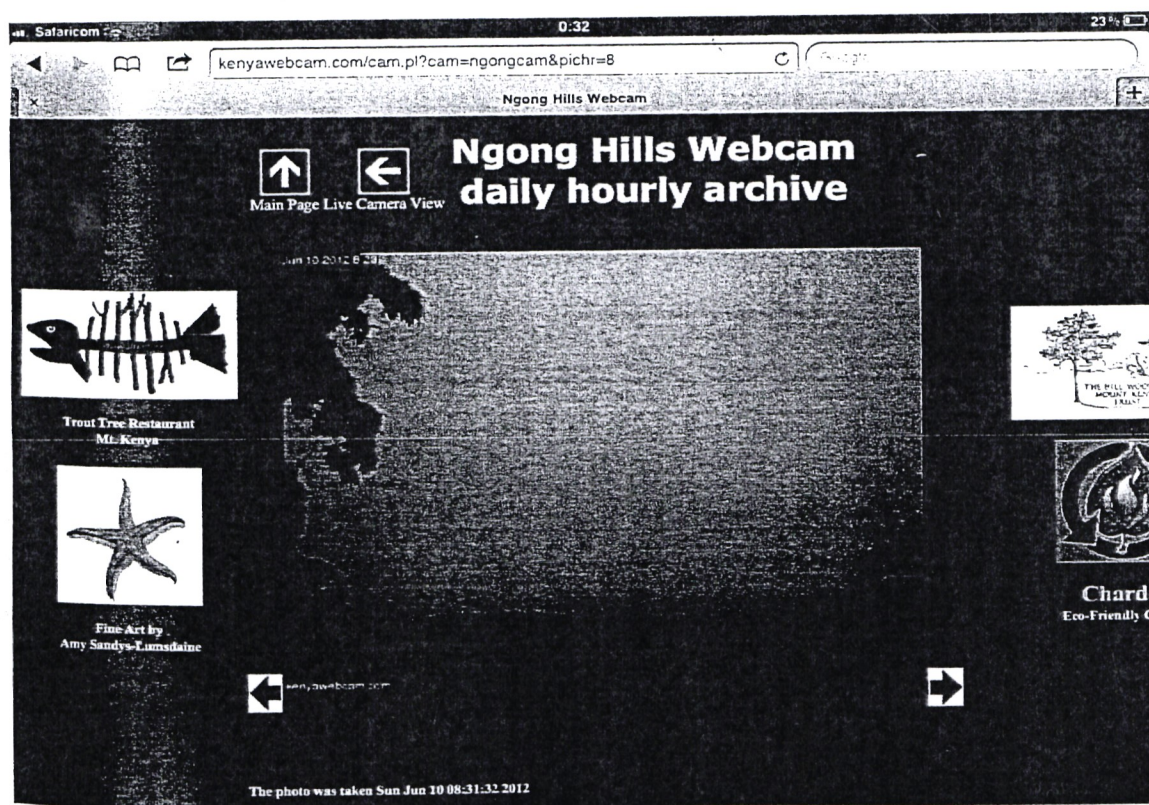
A snap shot taken at 0823LT, on the 10th of June 2012, by the Karen webcam was produced before the Commission. A review of the snap shot taken from Karen shows the farthest visible and recognisable object as two tall Eucalyptus trees in the middle of the picture at a bearing of 222° magnetic from the webcam location. The Ngong Hills are not visible. But in a comparative picture taken by the same Karen webcam on the 14<sup>th</sup> June 2012 at 1530 the Ngong Hills are clearly visible. The two blue gum trees are located at an altitude of 6,020' ASL. The approximate GPS coordinates of the two blue gum trees are S01° 22.544□ and E036° 42.897□. The distance from the Karen webcam to the two eucalyptus trees was worked out to be 1.65km. This indicates that visibility from the Karen Webcam towards the west was less than 2 km.

Figure 11: Webcam Photo taken on Sunday 10th June 2012 at 0831

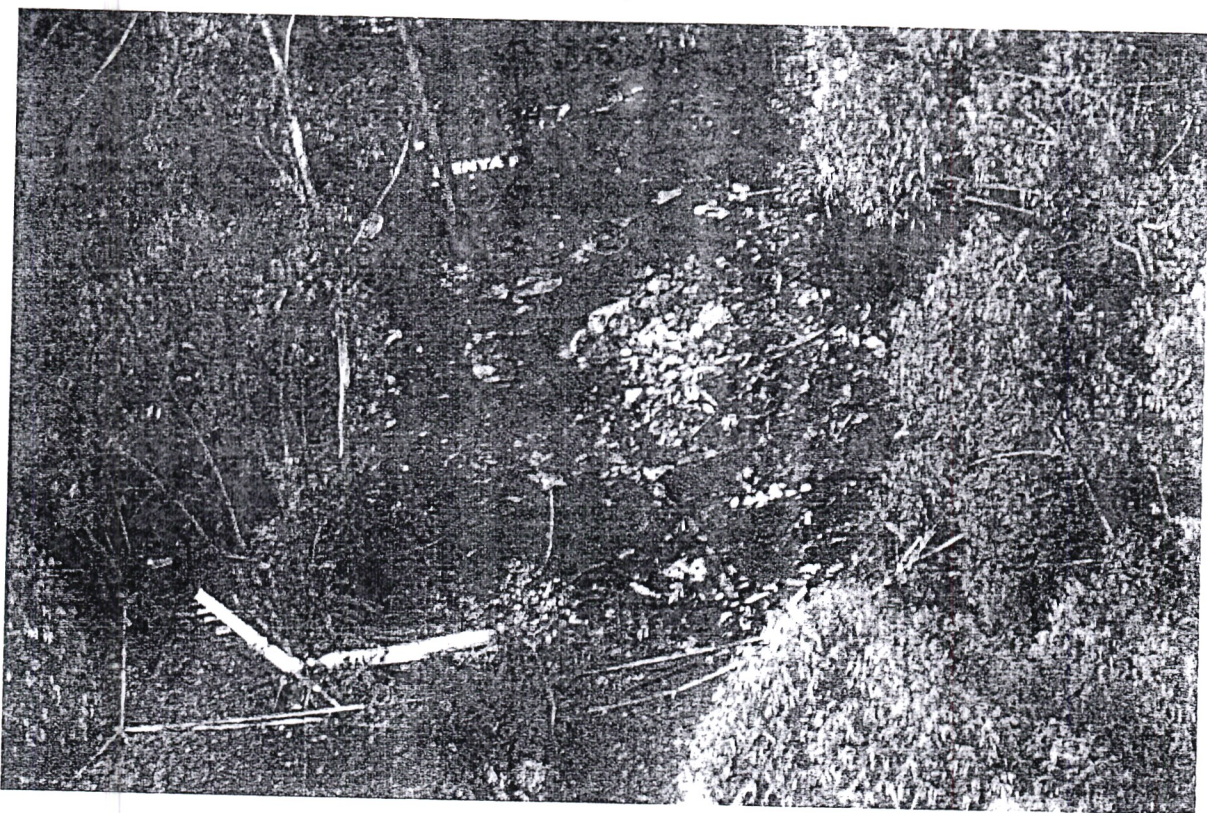
The wreckage was distributed over a rectangular area measuring 43m by 18m. The impact crater was situated at S01° 19.75' E036° 38.28' and the wreckage trail followed a general direction of 075° magnetic.

**Figure 13: Crash site**

Four of the occupants were violently thrown out as a result of the high energy impact and fuel tank explosion while the other two remained within the main wreckage area.

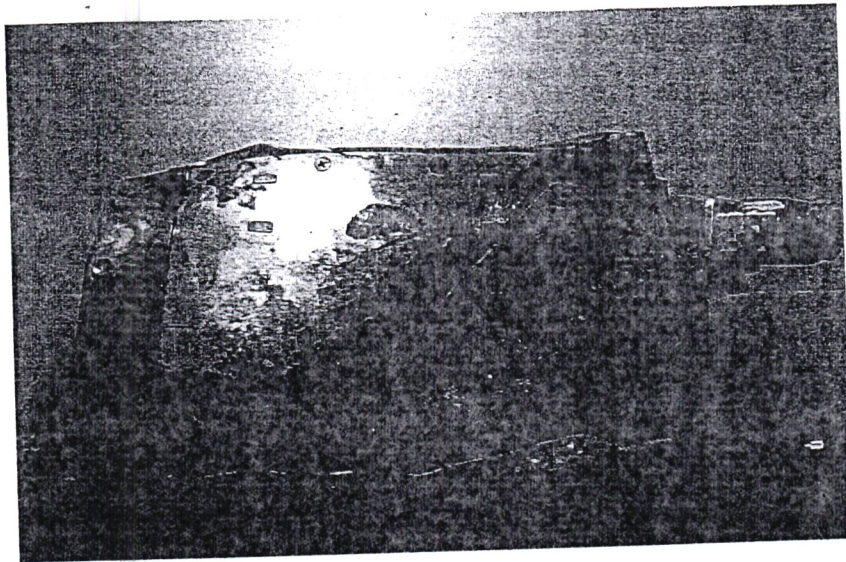
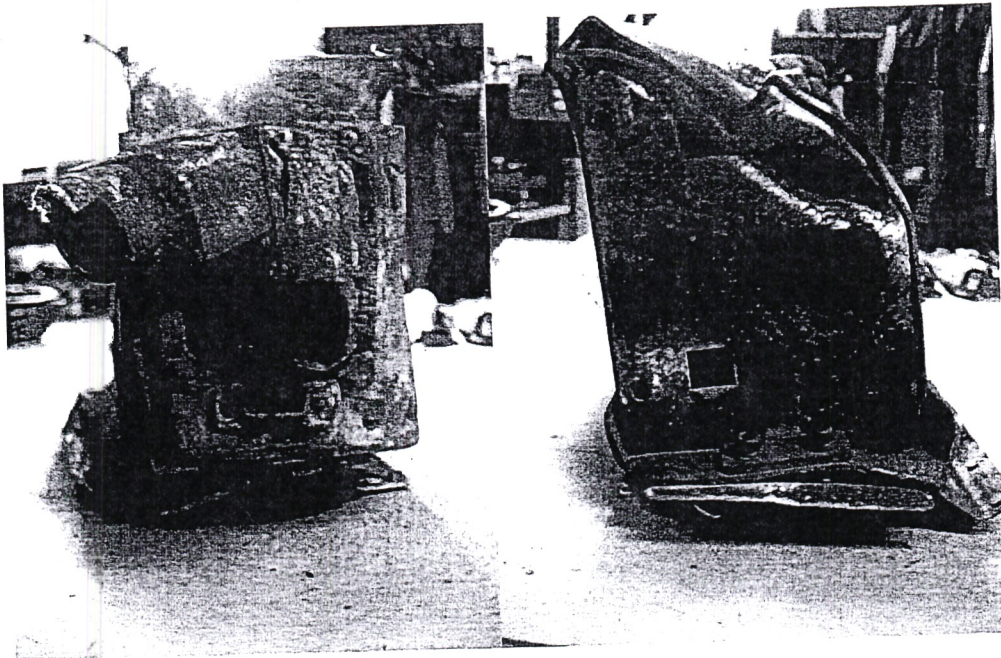
The initial inspection revealed extensive mechanical damage and overheating of the ISAT-200R as shown in the following figures.

Figure 16: ISAT Exterior

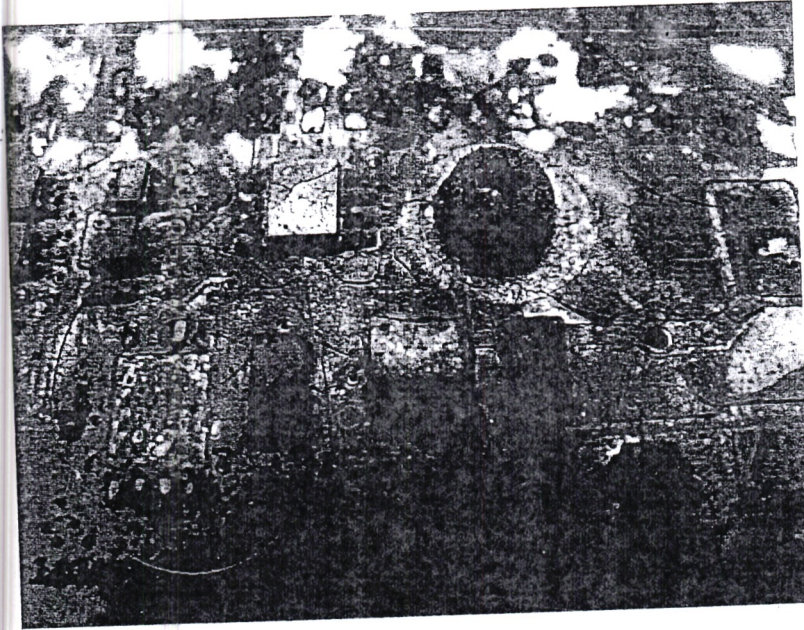
The heat generated at the time of the crash caused many of the Integrated Circuits (IC) to melt off the board, including the flash IC, which was located within the red circle in the following picture:

**Figure 23: Flash IC Printed Circuit Board Location**

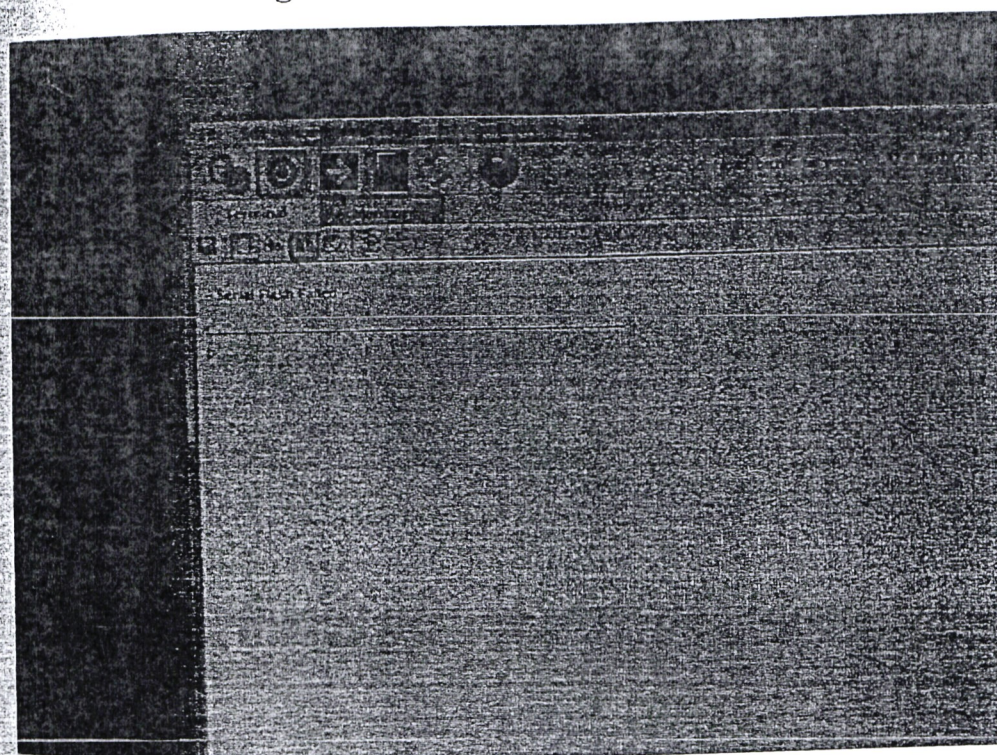
Power was then applied to the fully assembled ISAT as per the standard procedure, however upon receipt of multiple 'Serial Flash Failed' debug messages the extraction was terminated.

Figure 30: Debug Error Message

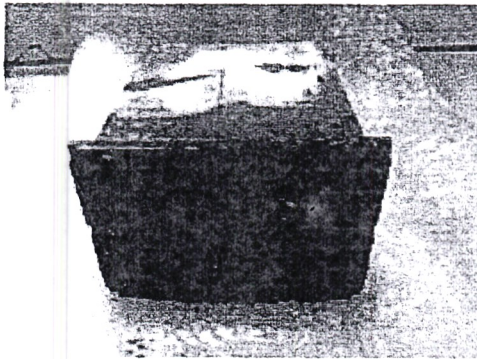
**Figure 31: VEMD recovered from the site**

The purpose of the readout was to establish the recorded “health” of the helicopter and engine systems prior to the crash. However no data could be retrieved or recovered from the VEMD or the FADEC.

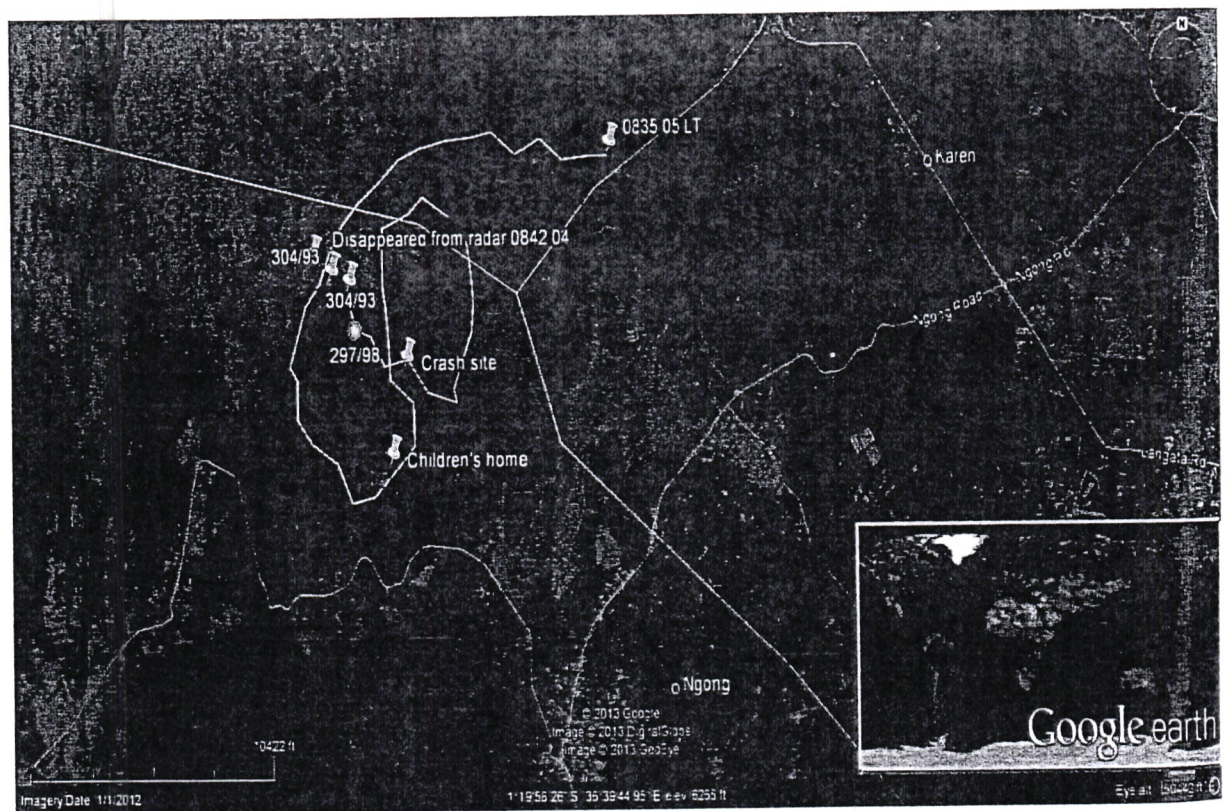
Radar data was used to plot an overlay path on Google earth from the point where the helicopter seemed to depart from its normal straight and level flight commencing a sharp climb and a turn to the left and the subsequent abrupt manoeuvres until it disappeared from radar screen at 0842:07LT. The final two radar returns were at 0841:58LT and 0842:04LT with no altitude indication and were located in the vicinity of the accident site.

Figure 32: Falcon 230 radar track shortly before the accident

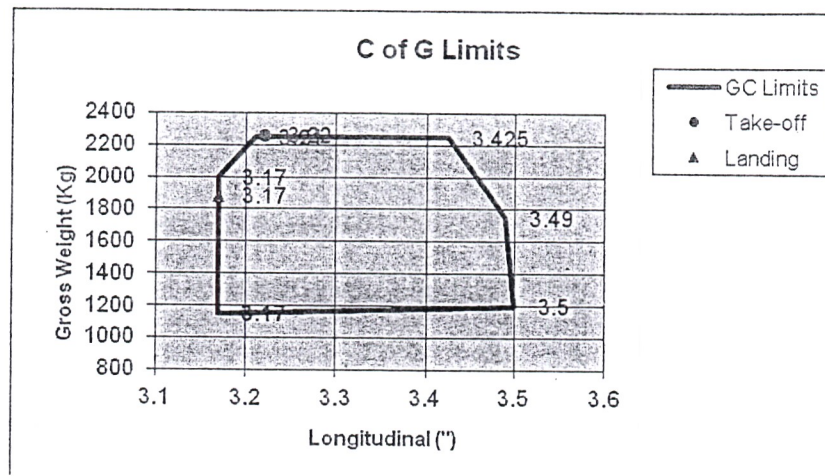
**Figure 34: CG of the subject aircraft**

The graph above indicates that the CG of the subject aircraft was at the edge of the flight envelope. Any abrupt manoeuvre therefore was placing the flight outside the safe margin of the flight envelope.

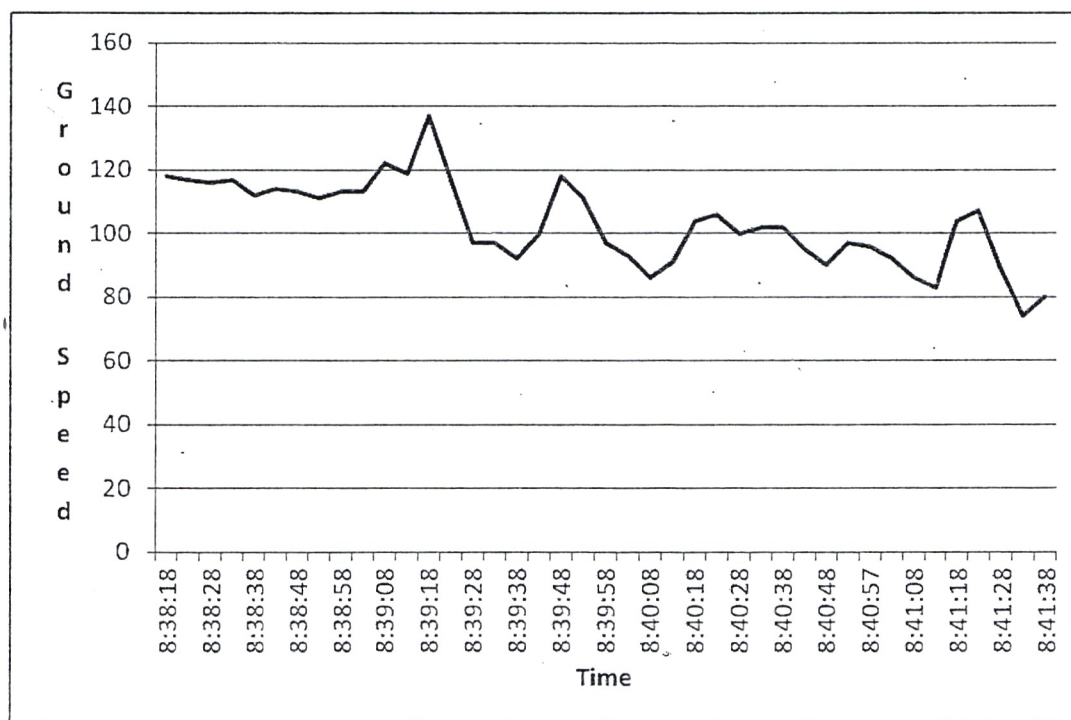
altitude until reaching the Nairobi Control Zone boundary in the Ngong area. The aircraft sharply turns to the left to a southerly heading then continues the left turn to head back north again. It continues on a left turn and then right turn and crashes heading 175°. Most of these turns were done in very steep bank angles with erratic changes in altitude. The ground speed recorded during these erratic manoeuvres was between 74 kts and 137 kts. The sound from a helicopter in such erratic manoeuvres would be varying cyclically due to the rapidly changing pitch of the rotor blades which would explain the eye witness account of unusual helicopter sound as it flew over Ngong area prior to the crash.

Figure 35: Erratic ground speed for the final sector of the flight

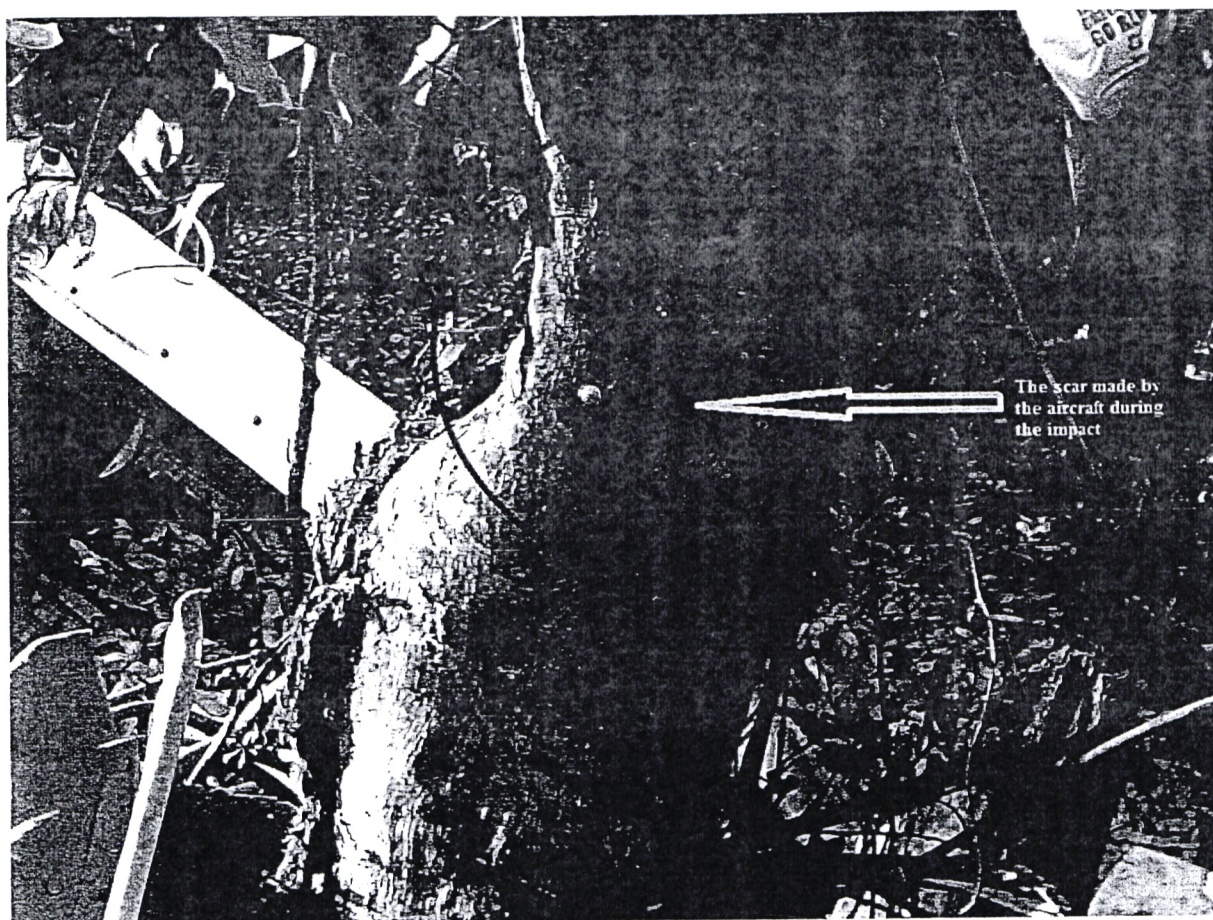
The on-site investigation revealed that the final trajectory of the flight before impact indicated a flight path angle of approximately  $40^{\circ}$  to the horizontal as shown by figure 37.

**Figure 37: Estimate of the Final trajectory before Impact**

The tail boom protection skid slid cleanly into a one meter vertical tree stump with the left side of the aircraft resting on the ground. For this skid to slide in this manner the aircraft would have to be in a left bank of approximately 75 to 90 degrees. This is well beyond the normal flight envelope. The tree stump would have arrested some of the momentum of the helicopter as the tail boom sheared off. In spite of this, the helicopter impacted the ground with significant force that created a crater approximately half a meter deep. The helicopter totally disintegrated and pieces of wreckage were scattered over an area approximately 43m by 18 m. One of the main rotor blades was flung over 40m away. The embedded cockpit centre post and lower wire cutter indicate a significant nose down attitude.
