PERFORMANCE AUDIT REPORT ON
EXPANSION, IMPROVEMENT AND MAINTENANCE
OF INFRASTRUCTURE IN PUBLIC PRIMARY
SCHOOLS
BY
THE MINISTRY OF EDUCATION

NOVEMBER 2021

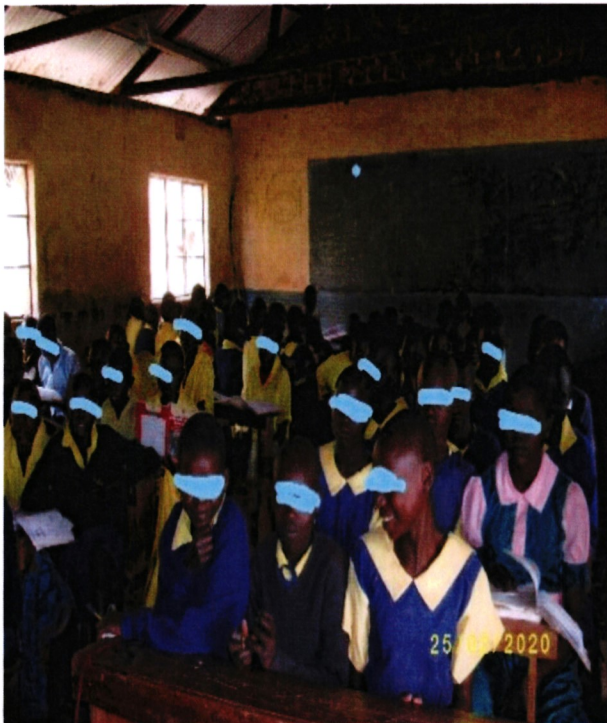
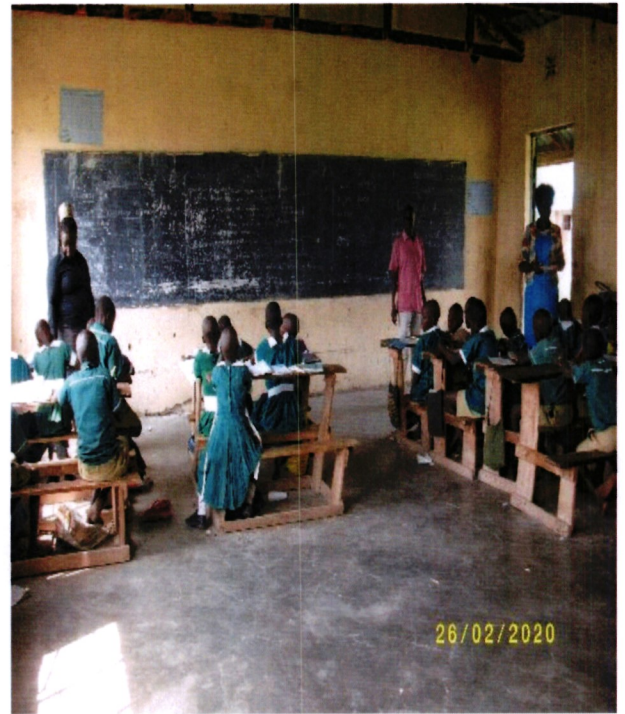
Figure 4: Classrooms shared between different classes

4.15 The deficiency of classrooms forced some schools to share one classroom between 2 different classes. This was observed in Moi Kabartonjo, Kotoron, St. Joseph Kasogokapel, Kenya Gauze and St. Charles Akudiet primary schools. In Kenya Gauze Primary school, lower classes (class 1-3) held classes outside because the school had 5 classrooms therefore a shortfall of 3 classrooms. **Figure 4** shows photos of students sharing a classroom.

Left: Sesik Primary School, Bungoma County-Two classes held in one classroom, at the front facing the camera is one class and at the back facing the opposite direction is the second class.

Right: St. John's Kasogol Kapel RC Primary in Amagoro, Busia- Two classes ongoing in one classroom at the same time.

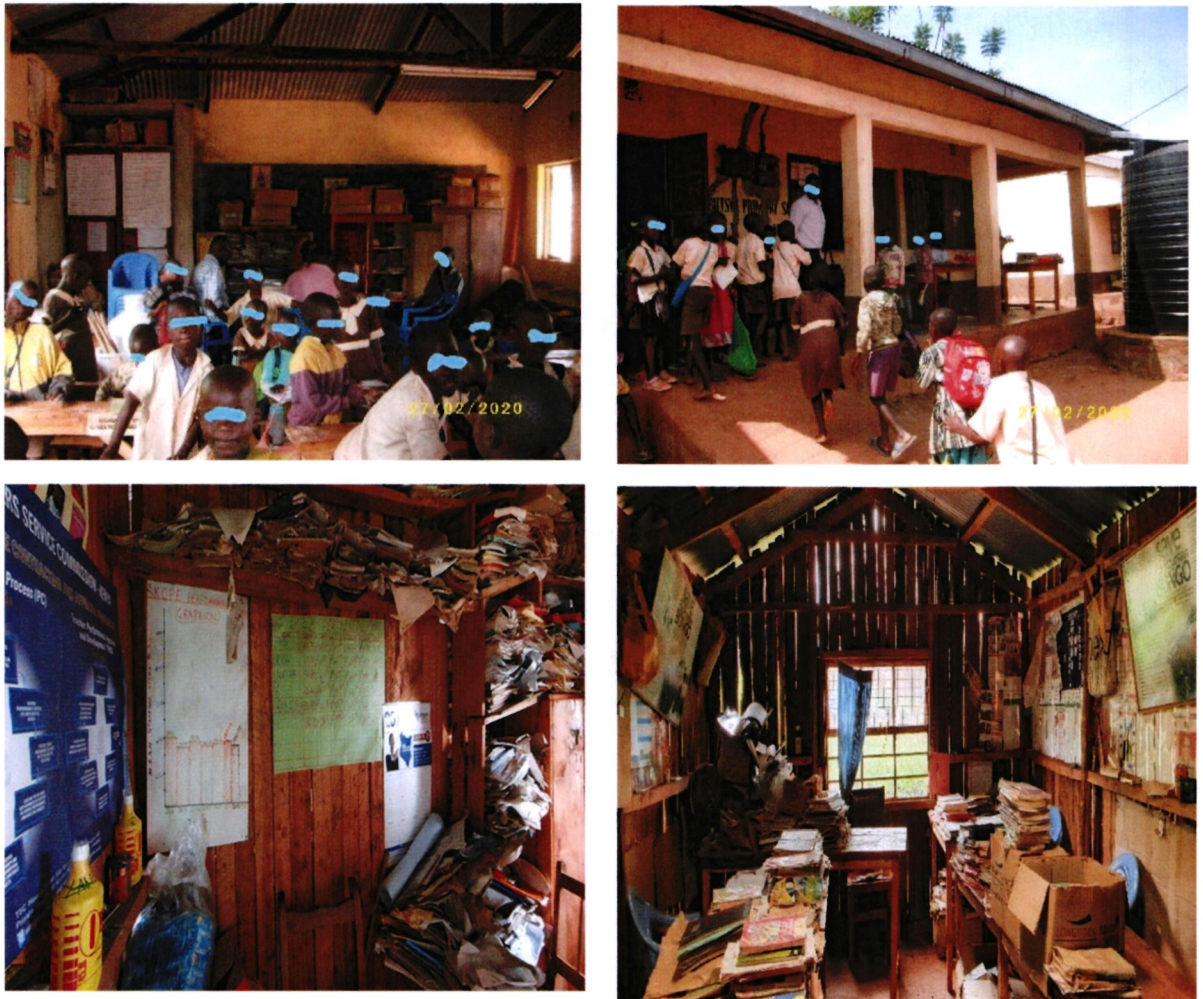
Figure 5: Photos of Administration offices in Some of the Schools

4.16 In addition, students lacked adequate desks with more than three students sharing a desk in majority of the school's sampled. In three of the schools Atoya, Ganze and Kisauni Primary School the Headteachers stated that, in some classrooms, students had to sit on the floor due to lack of desks. It was also noted that schools' administration offices lacked adequate space for teachers as well as storage for school records and equipment. **Figure 5** depicts conditions of administration offices in some of the sampled schools.

Top- Left-The audit team with the headteacher at the back of a classroom which serves as his office in Nabutswi Primary School in Bunyala-Busia County. **Right:** Teachers sit outside a classroom due to lack of a staffroom at the same school
Bottom: left- Headteachers office at Charagita Primary School in Nyandarua County School
Right- A staffroom at Kariki Primary School in Nyandarua County

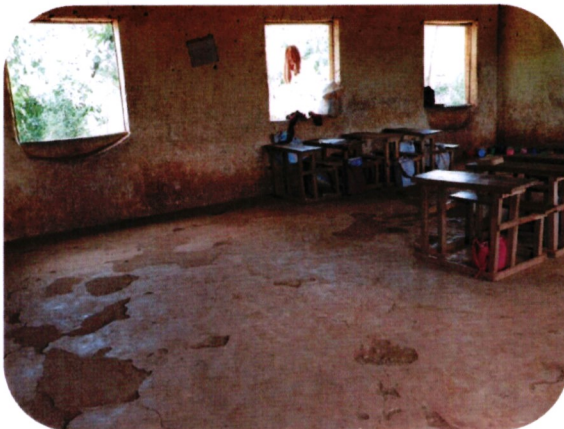
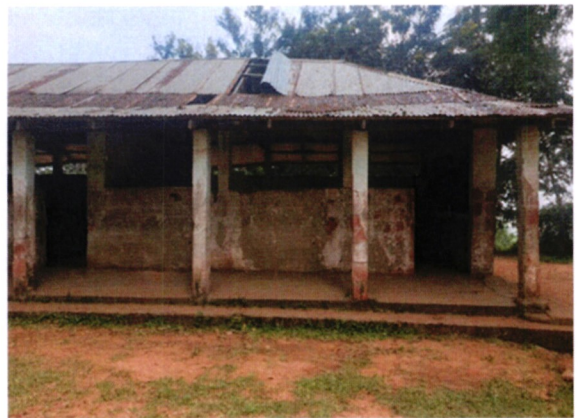
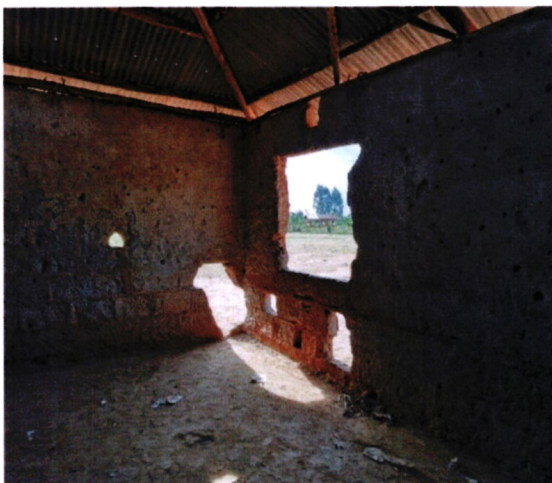
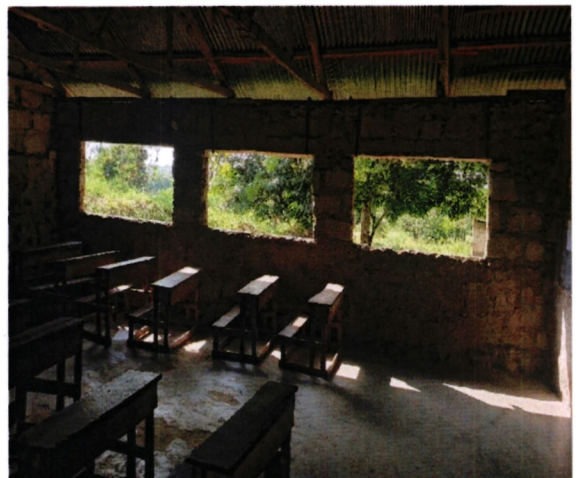
Figure 6: Status of Facilities in Some of the Schools

4.18 Data obtained by the audit team through physical observation shows that in addition to the deficit in numbers, the physical infrastructure in schools sampled required urgent repairs and improvement. The team observed classrooms that were semi-permanent (made of iron sheets, timber or mud) while others were incomplete. It was noted that some classrooms did not have doors and windows, while others had chipped floors and rough unplastered walls. A number of the structures that were complete and permanent in nature needed re-painting as paints had faded off. In a school like St Michaels and Kikambala Primary school in Kilifi County classrooms were in a state of disrepair to the point that they could not be used by pupils. **Figure 6** shows conditions of infrastructure in some of the schools.

Top-left -Chipped classroom floor at Maumi Primary School in Makeni County, Right-One of the condemned classrooms at St Michaels Primary School-Kilifi County. Bottom: Left A classroom with cracks and holes at Lutaso Primary school in Bungoma County. Right-Classroom with unplastered wall and no windows at Migundini Primary School, Kilifi County

4.20 The existence of classrooms in state of disrepair as well as incomplete state poses a risk to the health of the pupils as injuries can easily occur. For example, children jumping over open windows may injure themselves while at the same time weaken the rough walls which may lead to faster deterioration of the structures. Pupils are also exposed to extreme weather conditions like heat, strong winds and rain which interfere with learning.

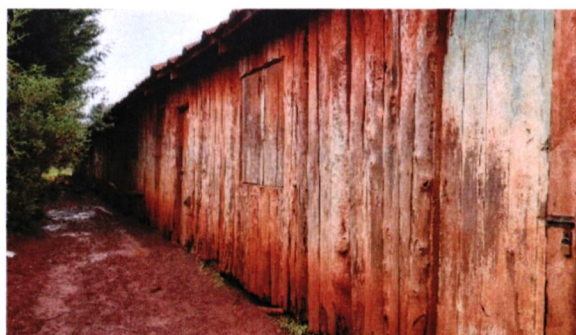
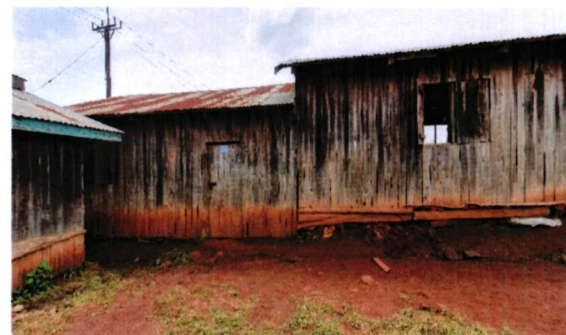
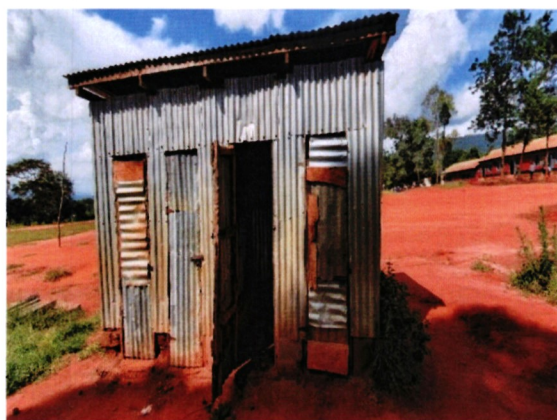
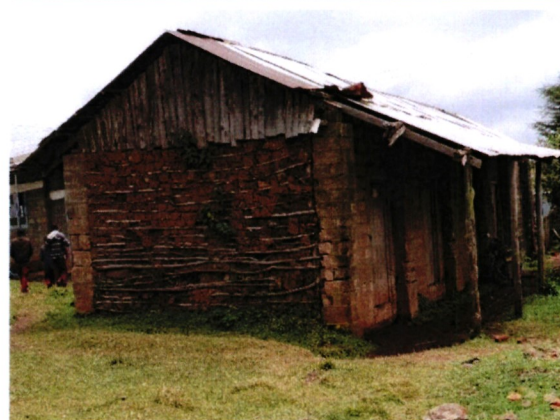
Figure 7: Semi Permanent Classrooms and Toilets in some of the Schools

4.19 **Table 4** shows 19 (35%) out of the 55 schools that had semi permanent classroom. In two of these schools, Latacha and Moi Primary, all the classrooms were semi permanent. **Figure 7** shows semi permanent classrooms and toilets.

Top-Left: A block of semi-permanent classroom at Chamuka Primary School in Nyandarua County. **Right-**Classrooms at Charagita Primary School in Nyandarua County. **Bottom-left-**A toilet block at Kyanguma Primary Schools in Makeni County, **Right-** A classroom at Malan Primary School, Nyandarua County
