PERFORMANCE AUDIT REPORT ON
PROVISION OF SEWERAGE IN MAJOR TOWNS
IN KENYA:
A CASE STUDY OF KISUMU CITY

LAKE VICTORIA SOUTH WATER SERVICES BOARD

APRIL 2018

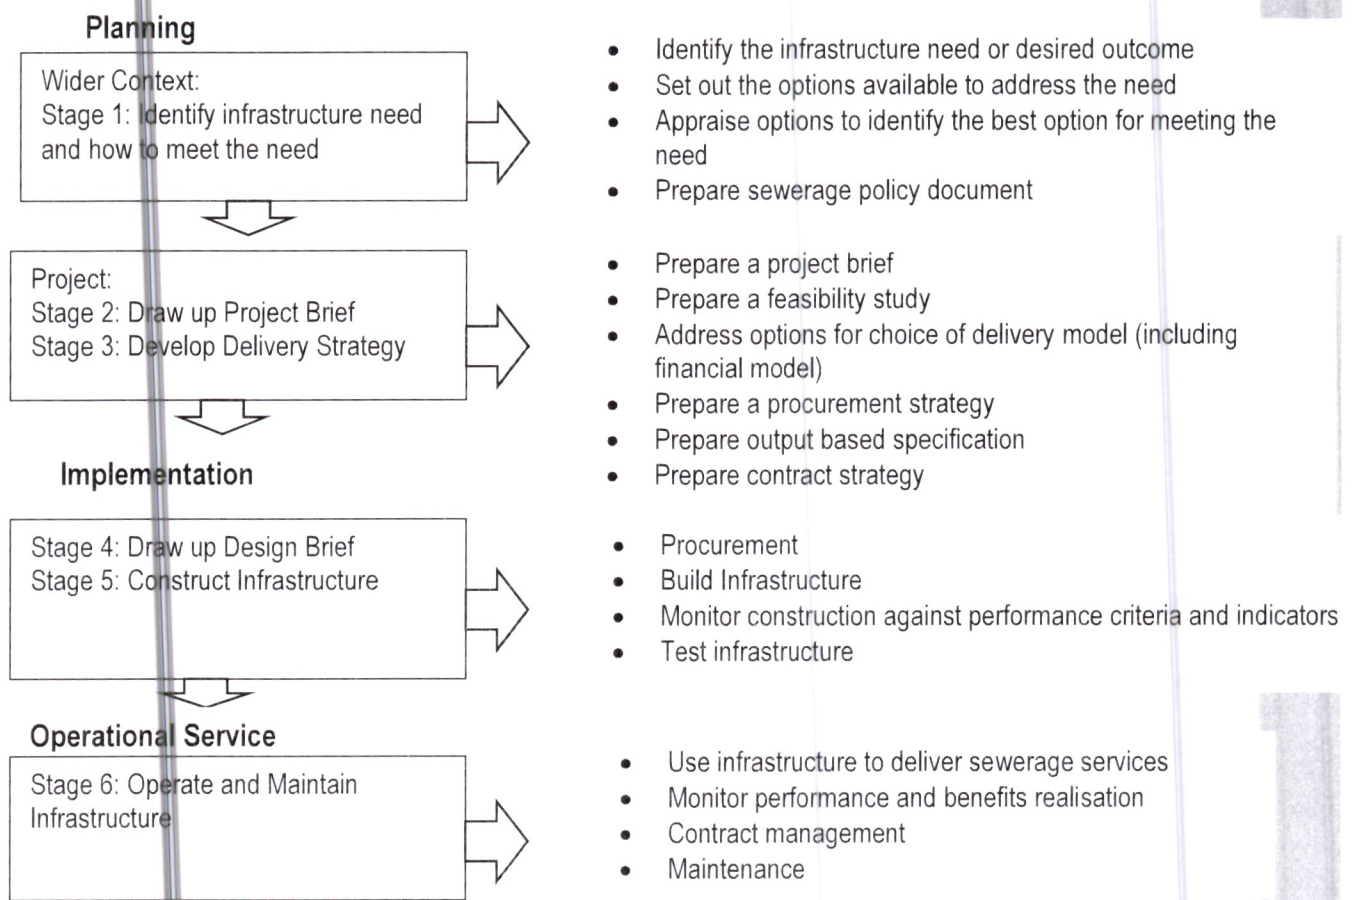
Figure 3: Description of the Process for Developing Sewerage

Generally, undertakings to develop sewerage system take the form of infrastructure development projects. Invariably sewerage development goes through six stages, which can be categorised into three steps, i.e. planning, implementation and operational service as shown in **Figure 3**.

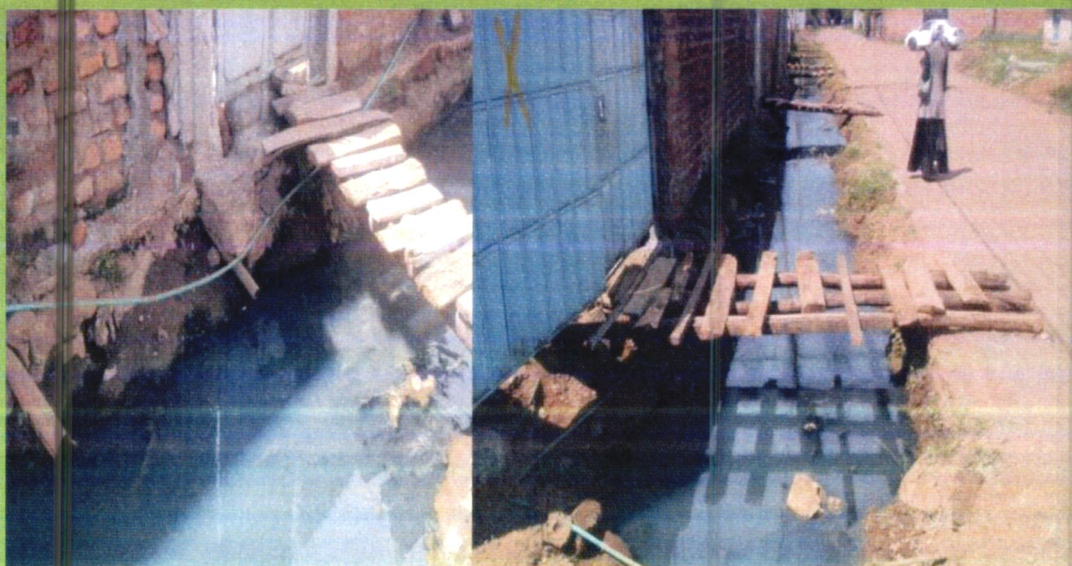
Lower Migosi is a middle class estate in Kisumu city. The estate once had a sewer system, but poor planning and abandonment by the LVSWSB had seen houses constructed on top of sewer lines while other lines are totally blocked to pave way for construction of residential houses. As at the time of the audit, the sewer network in this estate was considered dead. The residents had resorted to use of soak pits, which are illegally discharged into storm drains forming streams of raw sewage. This not only poses a serious health hazard to Lower Migosi residents, but is also a major source of pollution to the environment.

The team was informed by staff of KIWASCO that the estate had been in this state for a long time even before the implementation of LTAP-3. We were also informed that the LVSWSB is currently planning for another major sewerage expansion project in Kisumu, but Lower Migosi is still not considered in its scope. Further enquiries revealed that the case of Lower Migosi had always been avoided by LVSWSB since it is considered political as rehabilitation of the sewer network would require demolition of several buildings currently constructed on the sewer line.

Notice the discharge of raw sewage from the residential units forming a stream of sewage in storm drains hence posing a serious health hazard to residents of Lower Migosi and the neighbouring estates.

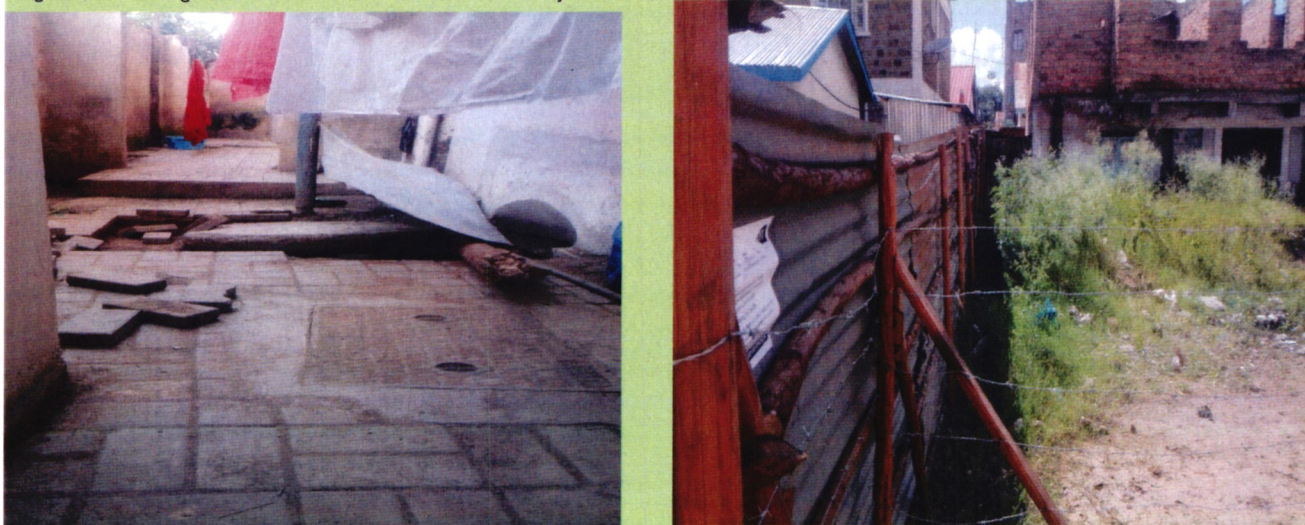
In Kisumu, it was noted that most of the wayleaves had been encroached. The audit team was informed that the implementation of LTAP-3 was to some extent delayed by challenges in acquiring wayleaves. For instance, LVSWBS fruitlessly negotiated with wayleave encroachers in Nyalenda estate for a whole year after which the board decided to redesign the sewer line. Some private land owners, for example in Milimani estate also refused to grant right of way, despite the board's willingness to pay. In estates such as Lower Migosi, buildings had been constructed on wayleaves hence posing a challenge to maintenance works.

Notice the sewer manhole within the pavement of the building on the left. On the right, the space between the two buildings is for the main sewer line

The problem of wayleaves had been caused to a greater extent by conflicting sections of different sectoral laws. Scrutiny of documents revealed that the concept of riverine riparian reserve has been defined differently by various laws. For example, Section 116(2) of the Water Resources Management Rules, 2006 and Section 6(c) of EMCA (Water Quality) Regulations, 2006 provide for a minimum of six (6) metres to a maximum of 30 metres on either side of the river bank. On the other hand, Section 15(c) and (d) of the Physical Planning Act, Chapter 286 provides for not less than 10 metres in width on each bank, except in areas where there is an established flooding of a river or stream. This matter is further compounded by weak enforcement of existing laws by relevant authorities and laxity on the part of LVSWBS to monitor existing sewer lines leading to buildings being constructed on wayleaves including those with existing sewer lines.

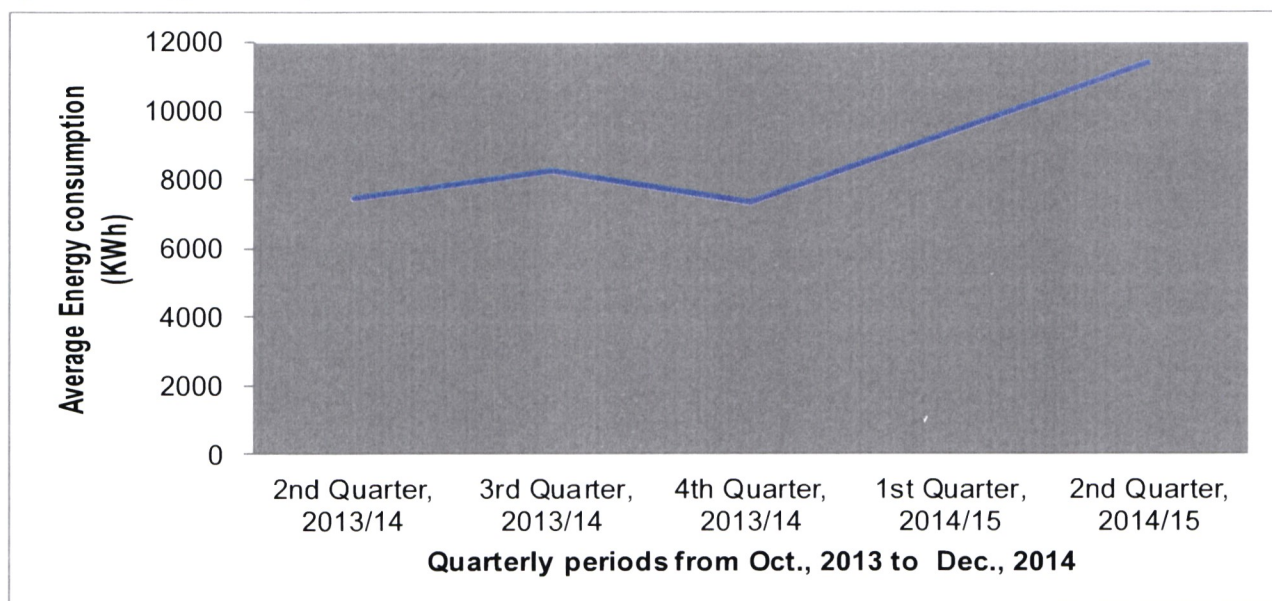
Figure 4: Energy Consumption for Kisat Treatment Plant, October 2013 to December 2014

from the plant to partially take care of the plant's energy needs.

Source: OAG's analysis of KIWASCO records

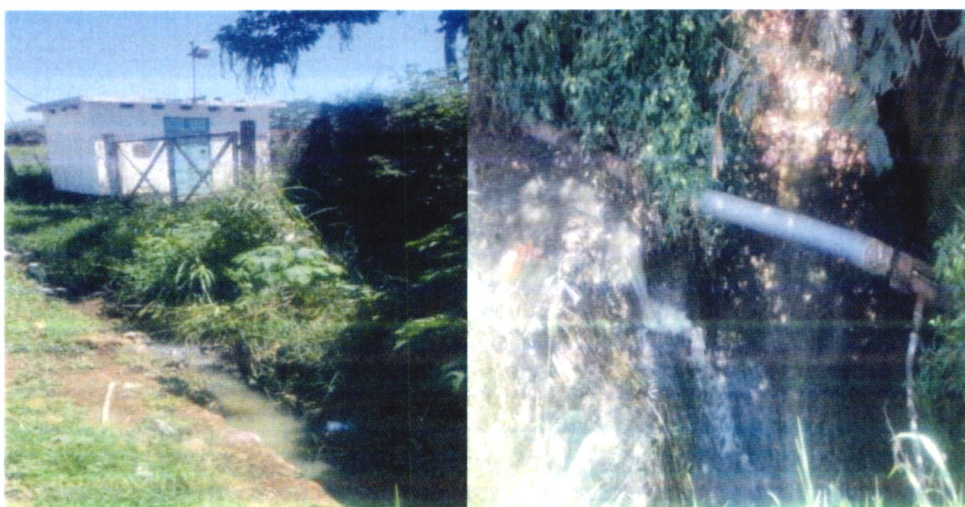
Plate 1: Waste water flowing into the environment from Kendu Lane pump Station

4.20 KIWASCO is, therefore, likely to incur high costs in operating and maintaining these facilities, which might even lead to their abandonment. During our field work in December, 2015, the team observed Kendu Lane pump station was poorly maintained, despite recent rehabilitation works. The pump station looked neglected with sewage flowing through a trench back to the environment as illustrated in **Plate 1**. The situation was the same during our earlier visit in April, 2015, but the pump operator blamed it on electrical power blackout during the time of our visit. It therefore appeared like KIWASCO is intentionally minimising the operation of this pump station because of the high costs involved.

Notice the waste water flowing from the pump station into a storm drain nearby

4.28 It was further observed that Kendu Lane pump station has continuously failed to operate. On enquiry, KIWASCO staff claimed that the station was connected to a low power supply that has continuously failed to run the system. As a result, waste water overflows at the station, ending up in the storm drains adjacent to it and eventually to Lake Victoria.

- To ensure that the existing sewerage is well maintained: -
 - LVSWBS in consultation with WASREB should clearly define the nature and extent of repair and maintenance responsibilities and be proactive in taking responsibility for the same
