REPORT OF THE TECHNICAL COMMITTEE ON

THE PROPOSED PURCHASE OF LR. NO. 7258/46 ALONG GIGIRI ROAD FOR CABINET OFFICE SPACE

ON 22ND FEBRUARY 2013

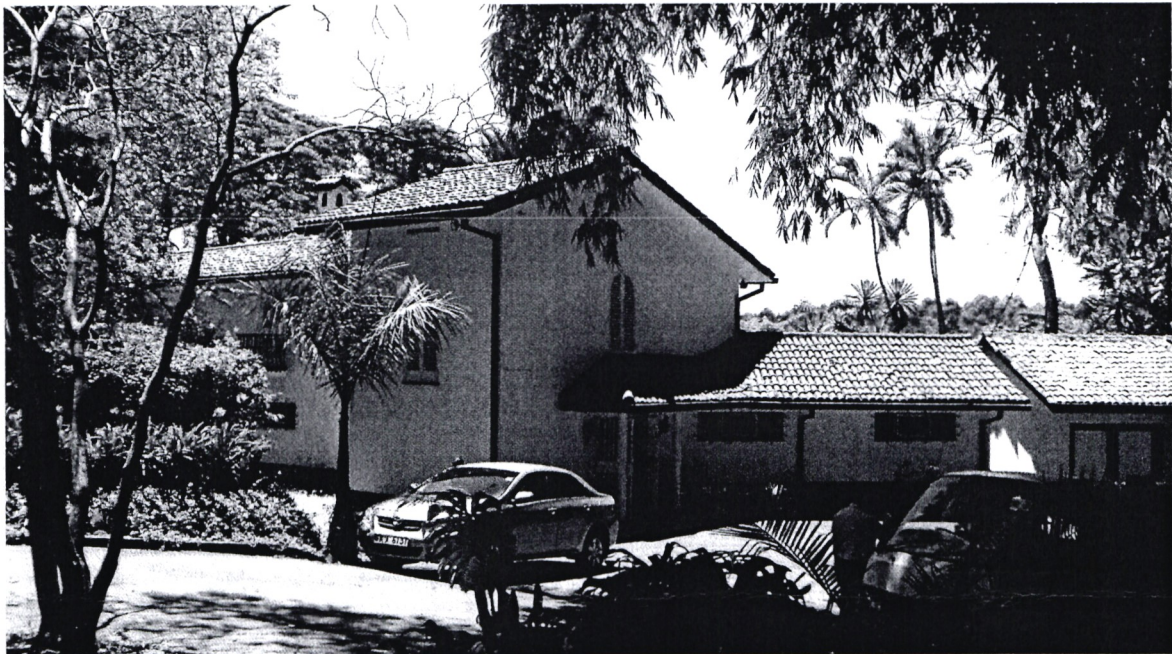
On the plot stands an old style double storey residential house whose total floor area is 360 square meters and a servant quarter. The building whose construction drawings were approved in 1966 is in good condition. It is constructed with load bearing natural stone walls and consists of the following accommodation;

Front view of the property showing the main building
