PARLIAMENT  
OF KENYA  
LIBRARY

SEPTEMBER 2023

I am pleased to present this performance audit report on: Conservation of Water Towers in Kenya by the Kenya Water Towers Agency. My Office carried out the audit under the mandate conferred to me by Article 229 (6) of the Constitution of Kenya, 2010, to confirm whether or not public money has been applied lawfully and in an effective way. In addition, Section 36 of the Public Audit Act, 2015 requires the Auditor-General to examine the economy, efficiency and effectiveness with which public money has been expended.

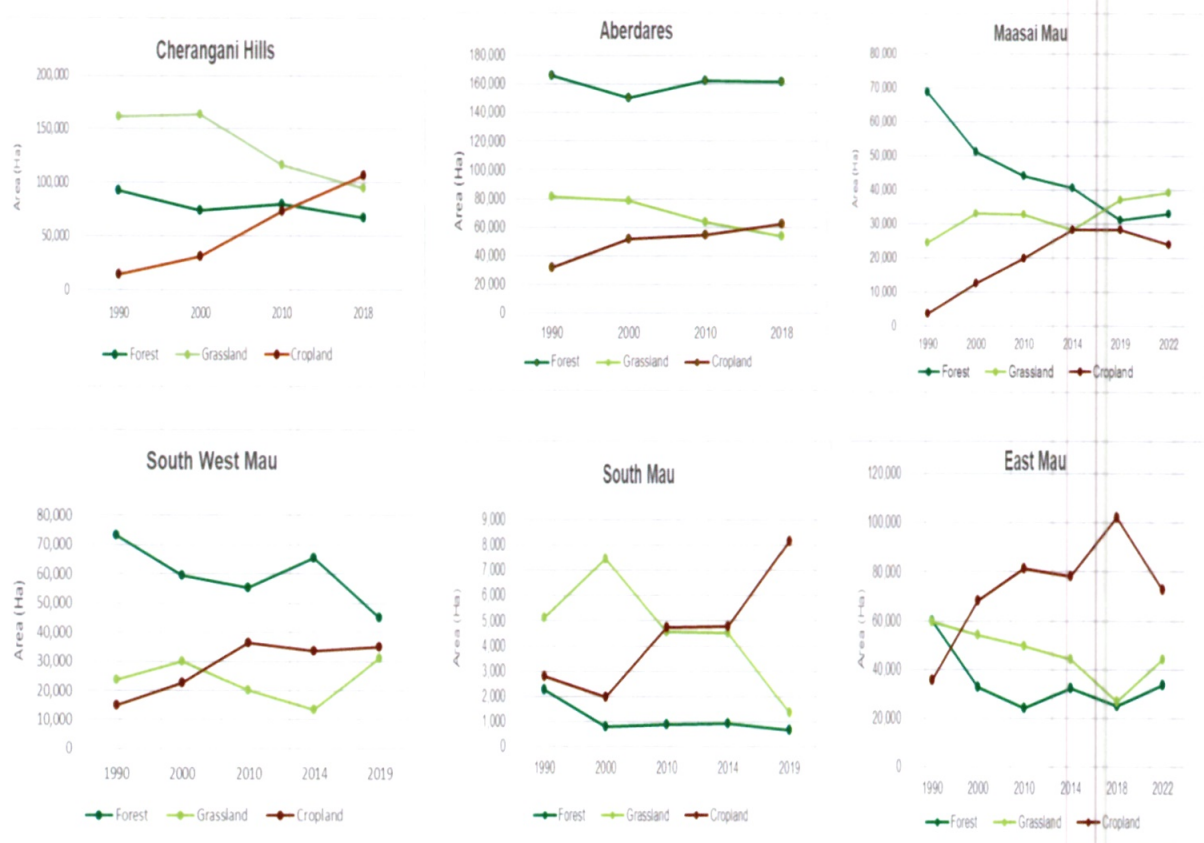
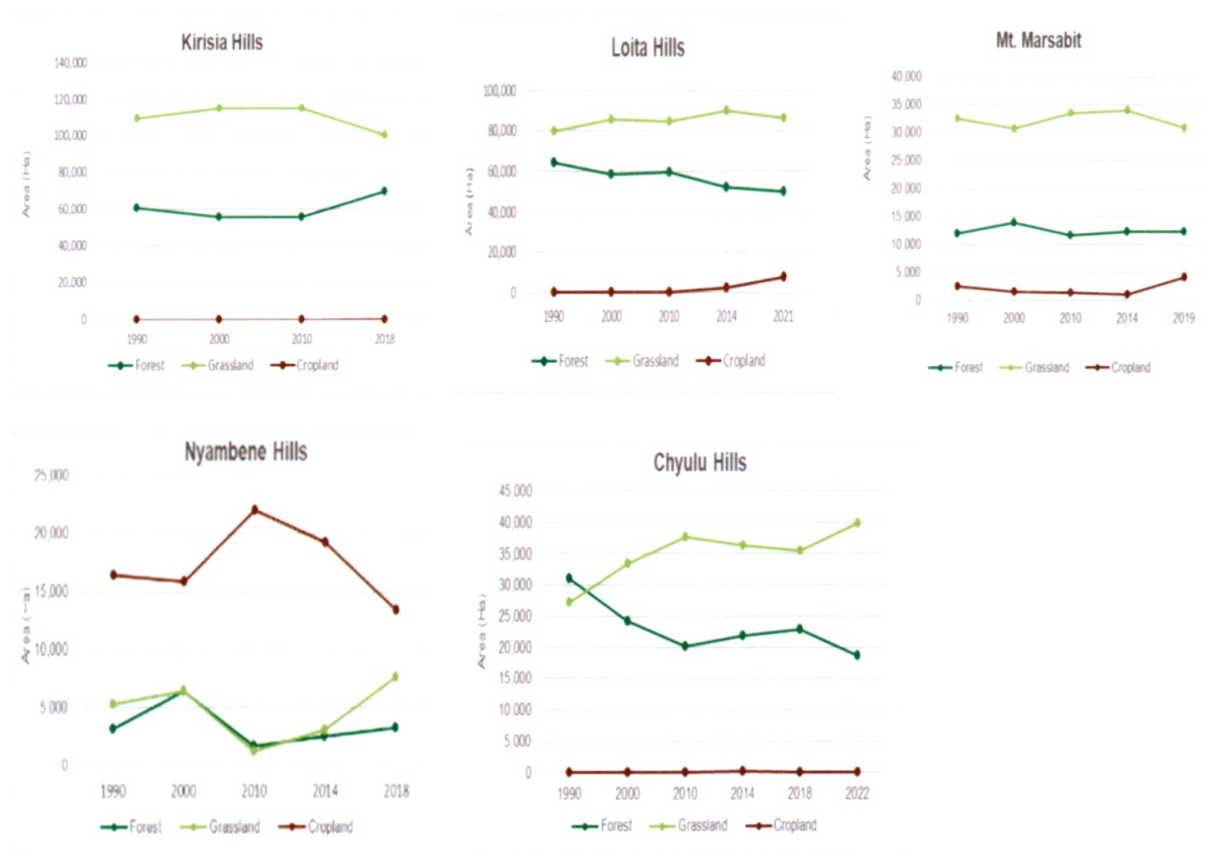
**Figure 4: Land Use and Land Cover Changes in the Sampled Water Towers Since 1990**

protected forest areas, for settlement and agricultural purposes. For example, review of land use and land cover data, since the year 1990, revealed a declining trend in forest cover in Cherangani, Chyulu, Loita water towers and Maasai Mau, South Mau, and South West Mau blocks as shown in **Figure 4**. The Aberdare Ranges, Cherangani, Loita Hills, Mt. Marsabit water towers and South Mau Block had increased trend in crop land, depicting encroachment. Maasai Mau and East Mau blocks recorded a sharp decline in forest cover with marginal increase since 2019, attributable to rehabilitation activities implemented. Human encroachment into water towers was also observed during physical verifications. For instance, the Embobut Forest Block in Cherangani Hills and Nkareta area in Maasai Mau Block had both human settlement and farming activities. This was observed even on steep slopes thereby increasing the risks of flooding, landslides and siltation of rivers.

- 4.32 As a result of insufficient reclamation, the Mau Forest Complex is still threatened by encroachers who often clear forest area to make room for settlement and crop production. For instance, analysis of land use land cover data for four (4) blocks in the Mau Forest Complex, that is Maasai Mau, East Mau, South Mau and South West Mau, revealed a general declining trend in forest cover while cropland increases as earlier shown in **Figure 4**. However, the Maasai Mau Block revealed slight improvement in forest cover attributable to reclamations done in 2018 and 2019.

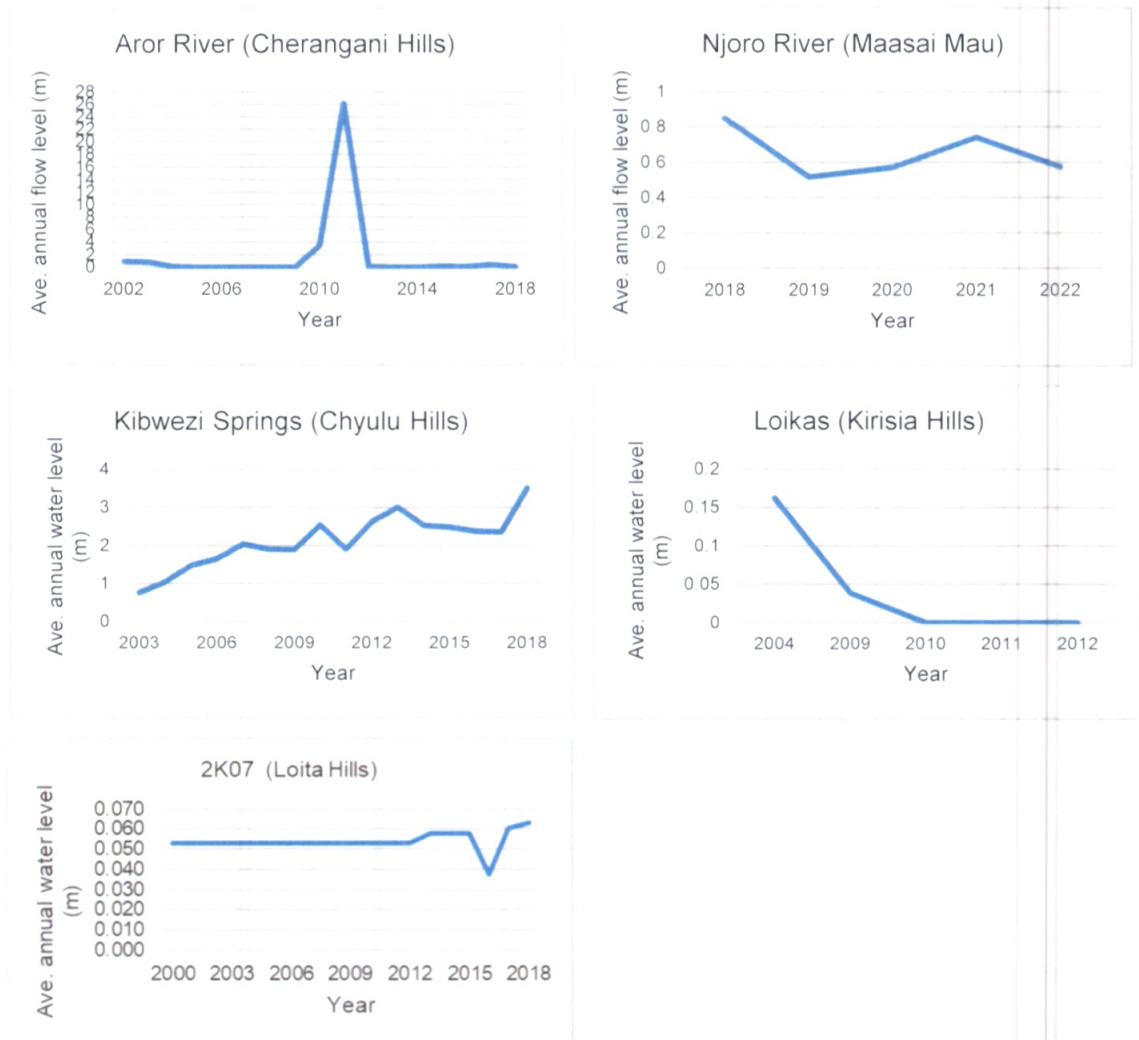
**Figure 5: Trend in Water Flow Levels**

- 4.9 The declining forest cover combined with an increase in crop land has had a negative impact on water availability, which contributes to the achievement of SDG 6 Target 1 on universal and equitable access to safe and affordable drinking water for all by 2030. Interviews with staff of the Agency and review of water tower status assessment reports revealed that most of the rivers and springs emanating from these water towers had recorded reduced volumes over the years due to destructive human activities in water towers. This was also confirmed through analysis of water quantity data maintained by the Water Resources Authority (WRA). However, due to limitations in the data, the audit could only confirm the trend in flow levels for water sources in five (5) out of the nine (9) sampled water towers. The data showed a declining trend in three (3) out of the five (5) water sources as shown in **Figure 5**.

- 4.20 Securing of critical water catchment lands is a necessary pre-requisite for conservation of such areas. The limited mapping and securing of such areas denied stakeholders the information needed to prioritize conservation activities and left such lands exposed to destructive human activities. From interviews and document reviews, the audit revealed that critical water catchment areas such as Lake Olbolosat in the Aberdare Ranges, as well as Ol Pusimoru Forest and Enapuipui Swamp in Maasai Mau had experienced some levels of degradation, thereby negatively affecting water availability. For example, analysis of water quantity data revealed a declining trend in Njoro River, whose source is Enapuipui Swamp, as earlier shown in **Figure 5**. Njoro River drains into L.
