**COMMISSION OF INQUIRY INTO THE ACCIDENT  
INVOLVING AIRCRAFT REGISTRATION 5Y-CDT**

**TYPE AS 350 B3e**

**COMMISSION OF INQUIRY INTO THE ACCIDENT INVOLVING  
AIRCRAFT REGISTRATION 5Y-CDT, TYPE AS350 B3e**

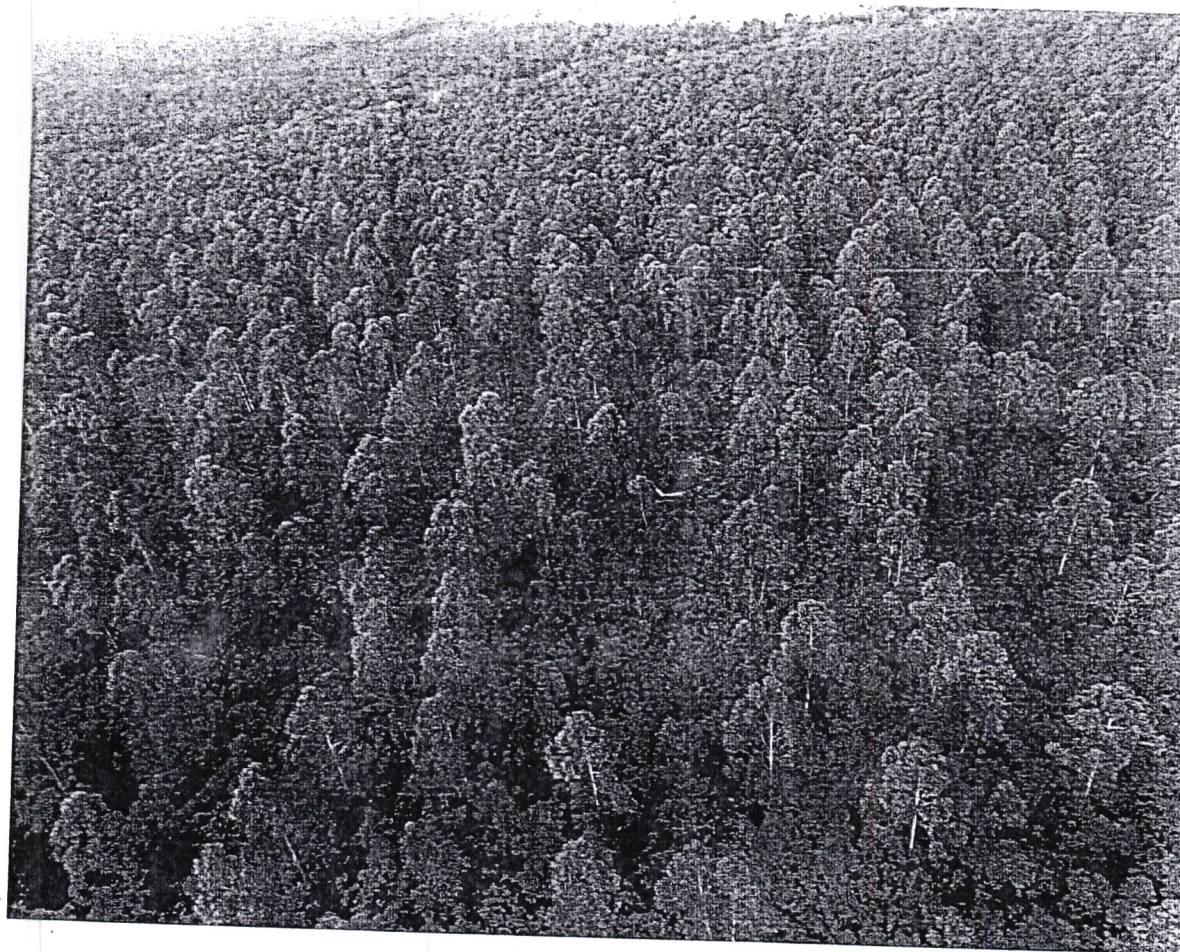
**Figure 2: Aerial photo of the site of the accident**

The impact point was at coordinates, S 01°19.738' E 036°38.292' at an elevation of 6620ft MSL.

The last radar contact point was at coordinates, S 01° 19.217' E 36°37.667'.

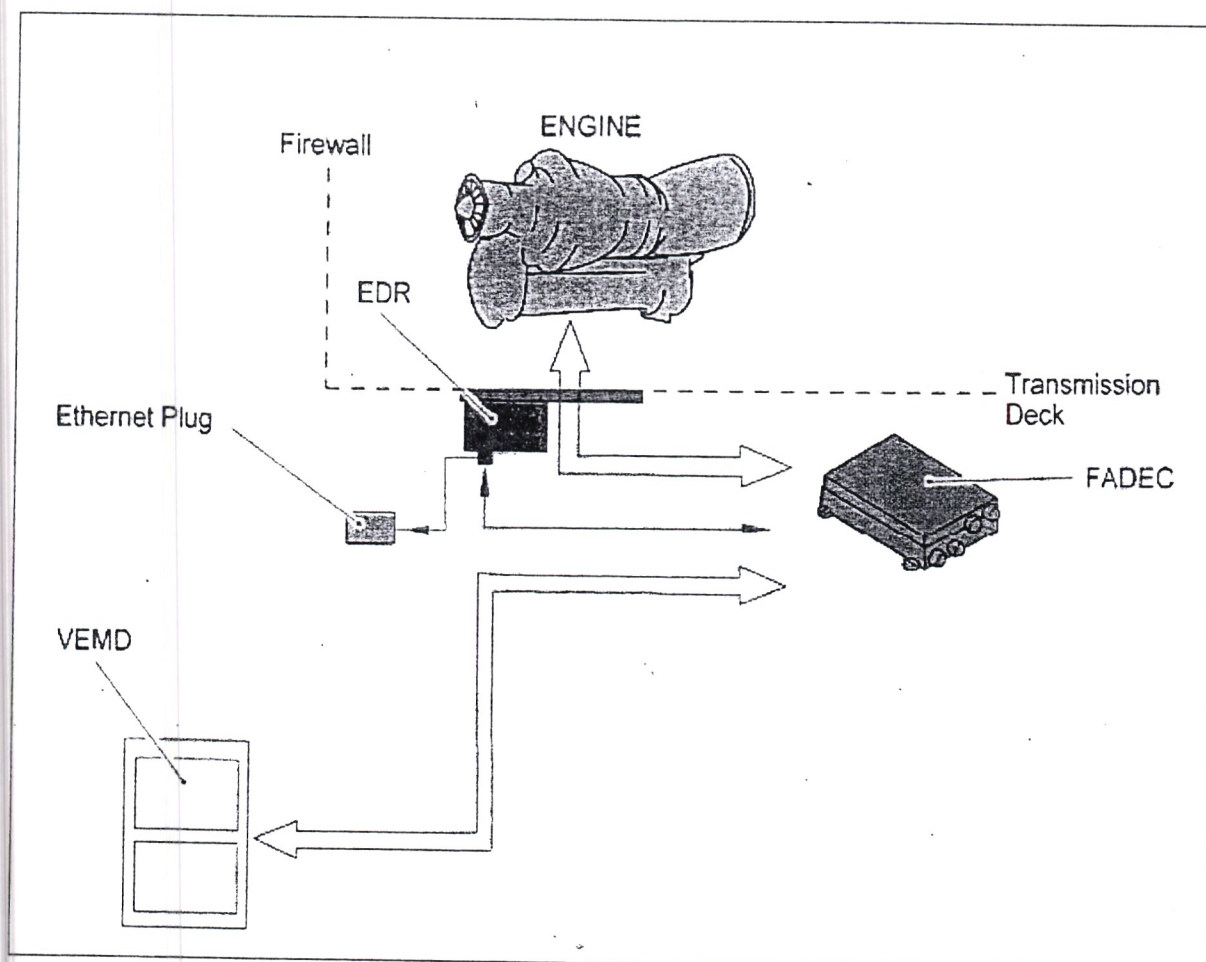
**Figure 5: Engine Data Recorder System**

The helicopter is fitted with a Full Authority Digital Electronic Control (FADEC) also referred to as Engine Electronic Control Unit (EECU) with a dual channel system which enables an automatic engine start cycle and the subsequent engine control. The dual system would act in redundancy; the second channel automatically taking over from the first failed channel and apart from the display of failure on the VEMD screen, operations would proceed normally. Should the second channel also fail during operation, the flight would proceed using the stand-by channel Emergency Back-up Control Auxiliary Unit (EBCAU), but thereafter the system would not permit an engine start while the defect persists. The system had totally failed on 31<sup>st</sup> May 2012 and was subsequently repaired by replacing the unserviceable Engine Electronic Control Unit (EECU).

*"The EDR is matched to its engine; it contains data required for controlling and managing the engine\_log book. It must systematically accompany the engine, and must not be used with another engine even during fault isolation operations."*

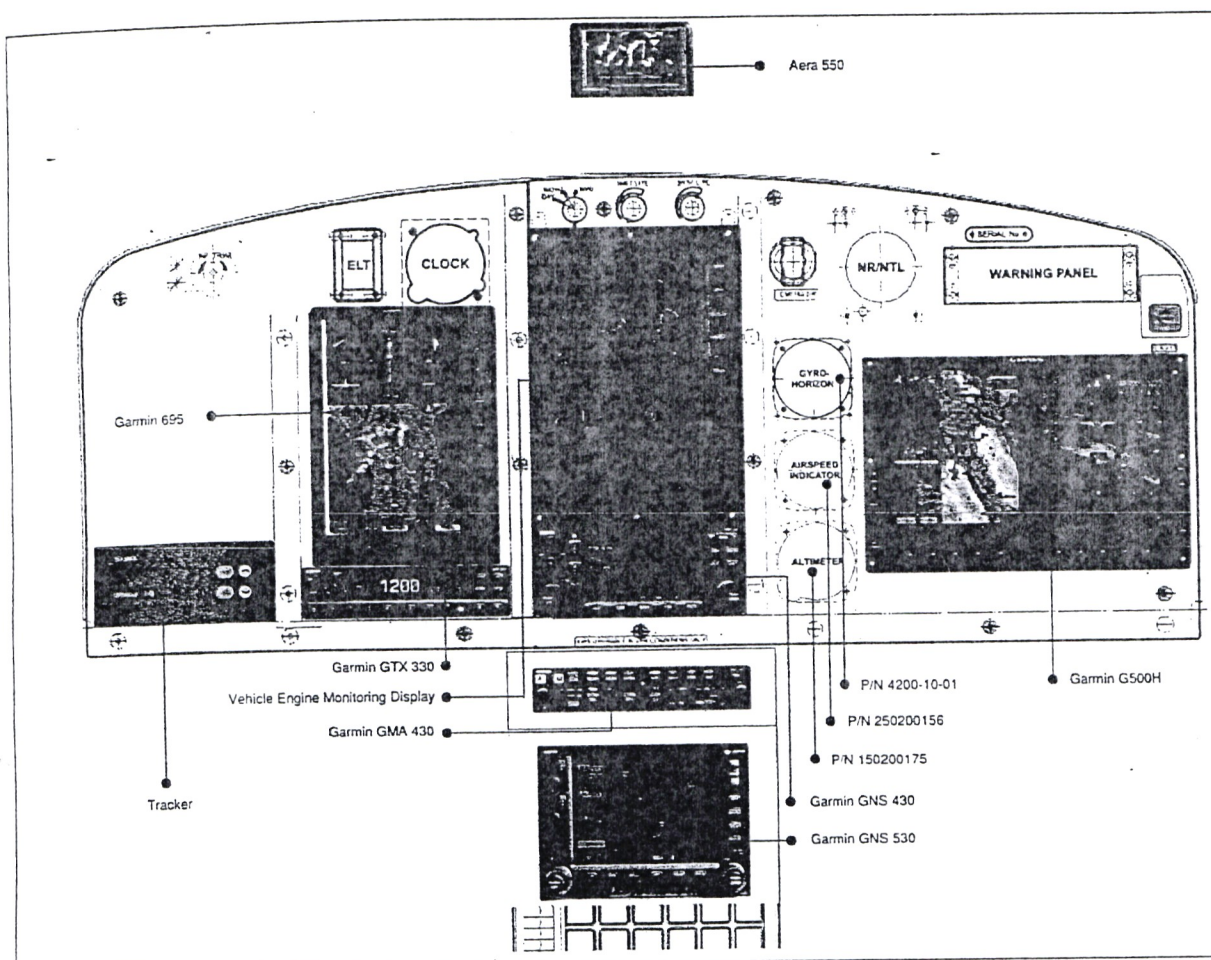
Figure 6: 5Y-CDT Cockpit layout as requested and approved by the Kenya Police Air Wing Commandant

The subject helicopter is a modern design featuring the glass cockpit configuration consisting of Garmin 500H dual screen electronic flight display (PFD and MFD). This necessitated the removal of certain cockpit analogue instruments to match the layout approved by the Police Air wing Commandant as stated by CW 56. This reconfiguration was carried out in South Africa prior to delivery of the aircraft in Nairobi.

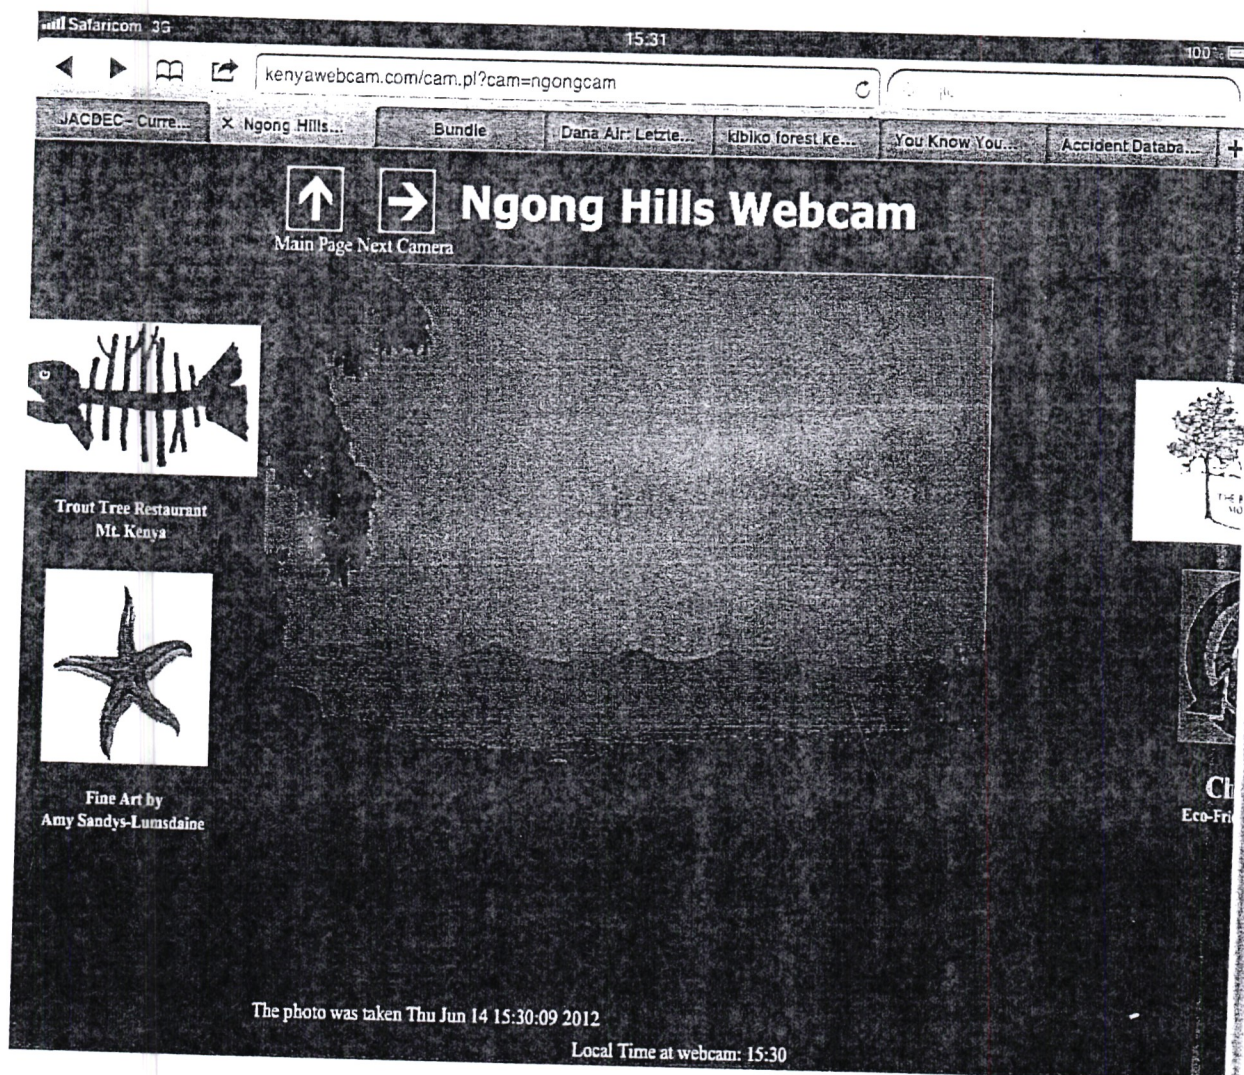
**Figure 12: WebCam Photograph taken on 14th June 2012 at 1230**

CW 36, CW 37 and CW 38, eye witnesses in the vicinity of the accident site, gave accounts before the Commission that left no doubt that there was mist and low visibility in Ngong area at the time of the accident. Estimates of visibility from the witnesses ranged from 100m to 500m. The helicopter was flying very low according to these witnesses.

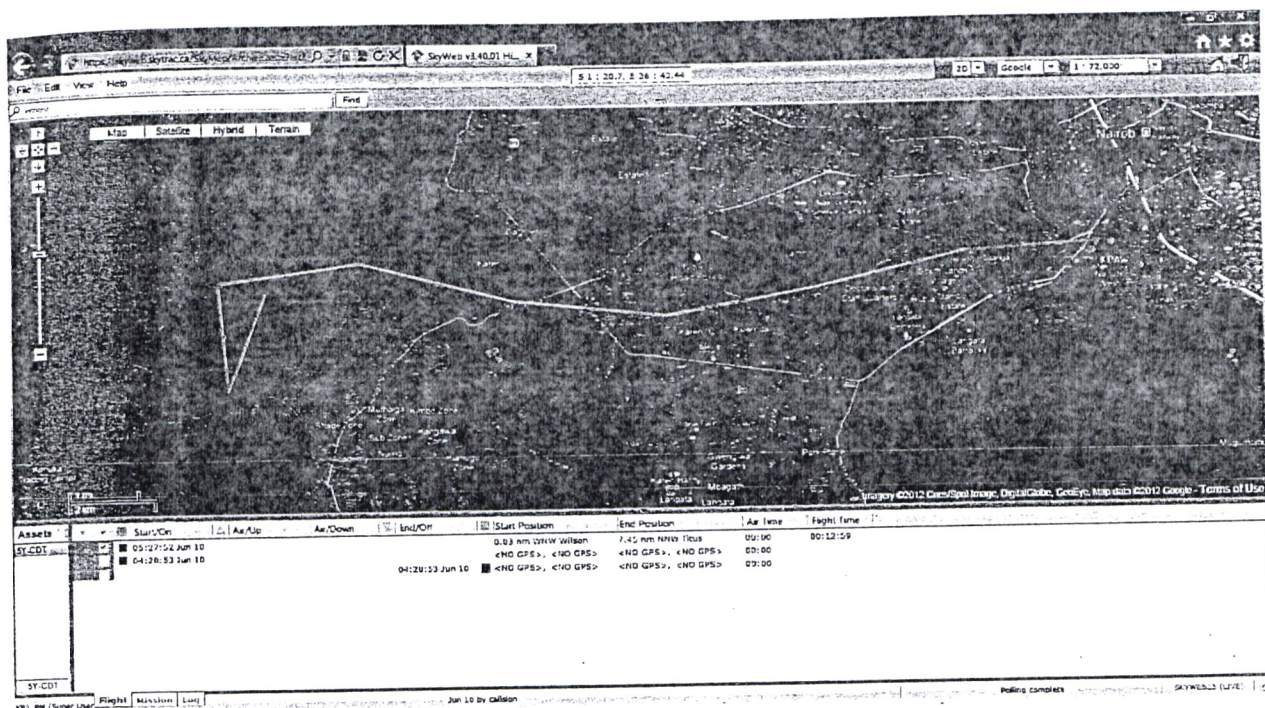
**Figure 15: Figure of Sky Web Server Data**

The following screen shot shows Sky Web server data for the subject aircraft on the material day as reported by the ISAT-200R at 60 second intervals.

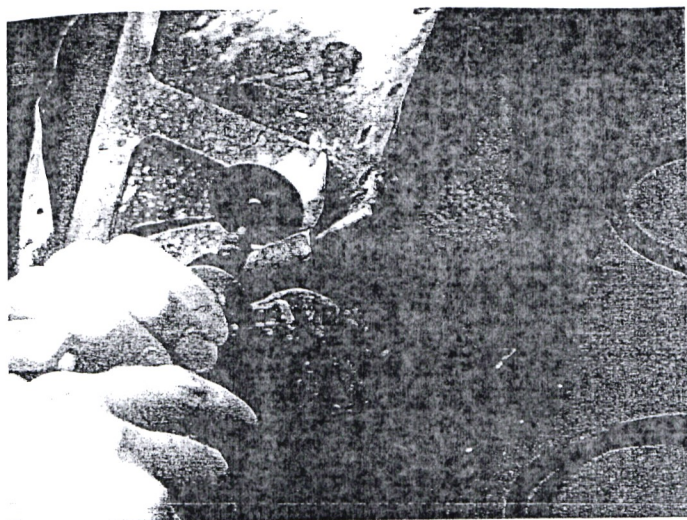
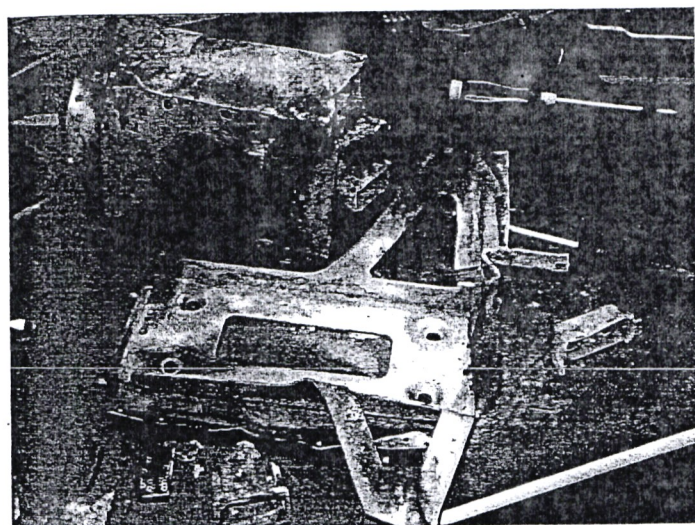
Due to the extensive damage the unit was not serviceable by standard procedures. In order to gain access to the internal circuitry, the ISAT needed to be cut out of the mounting tray. A Dremmel tool with a cutting wheel was used to remove the tray as shown in the following figures.

It is worth noting that balls of once-molten aluminium were found between the ISAT and the mounting tray, and the external ARINC connector was completely destroyed by heat.

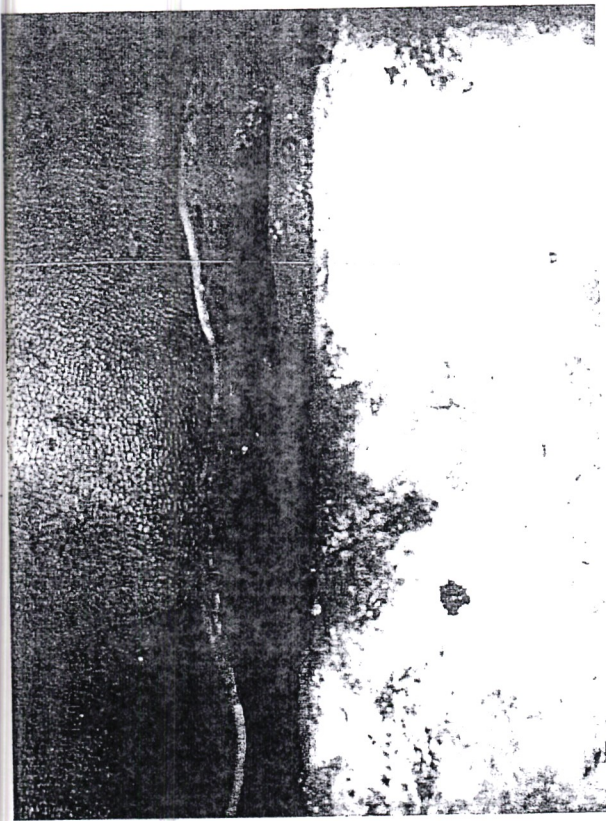
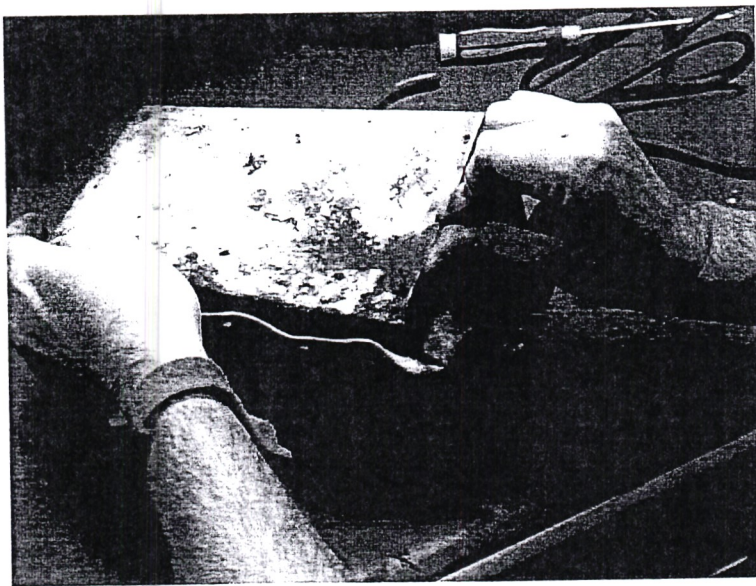
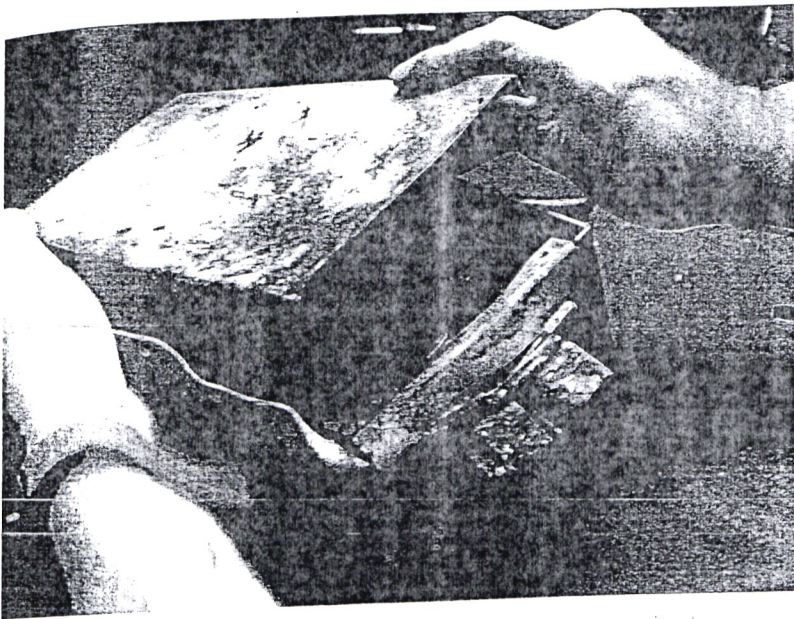
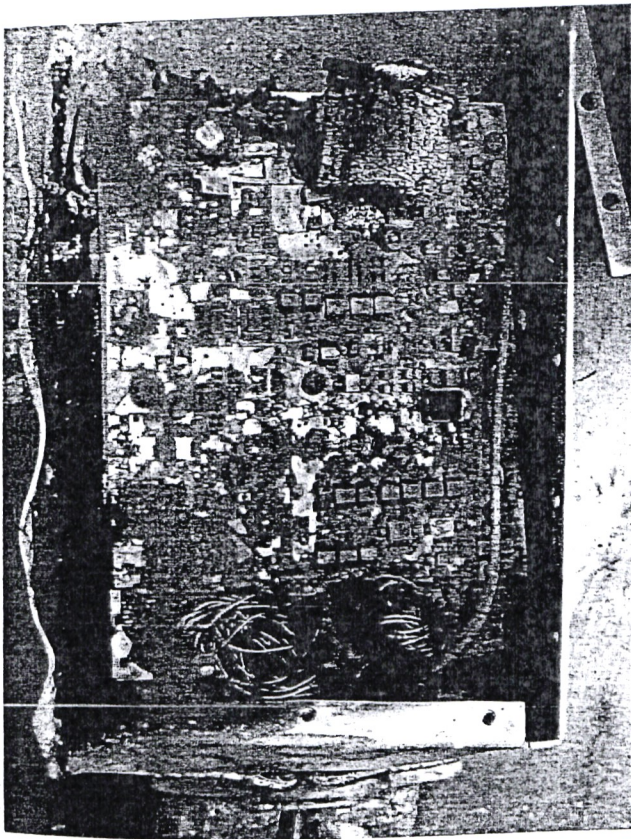
With the tray removed, the ISAT side-cover was opened to access the internal electronics. The following photos reveal the extent of the internal damage.

The heat generated at the time of the crash caused many of the Integrated Circuits (IC) to melt off the board, including the flash IC, which was located within the red circle in the following picture:

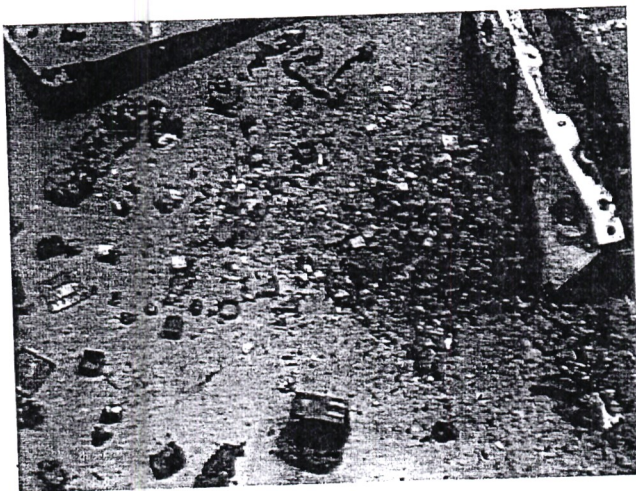
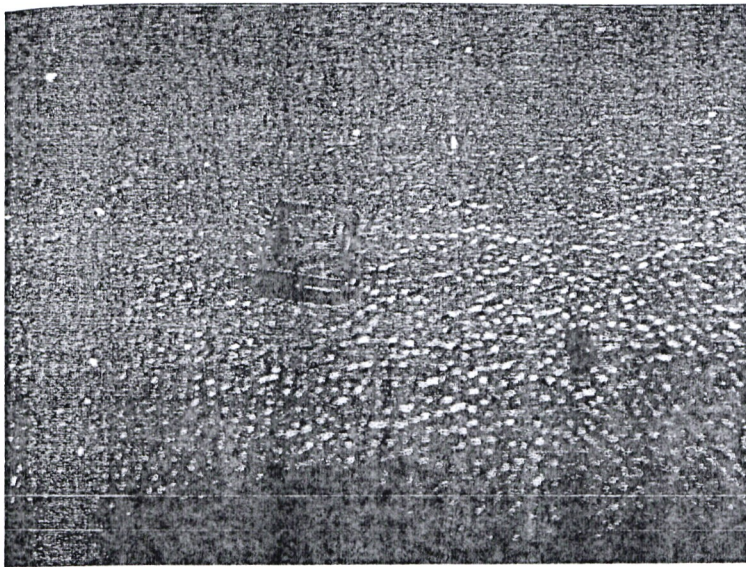
Within the debris that fell out of the unit, SkyTrac was able to locate the flash IC.

The pin-to-pin resistances of the recovered flash were evaluated against an identical new component to look for open-circuits or internal shorts. All resistances were found to be on the same order of magnitude so it was deemed safe to proceed with the extraction.

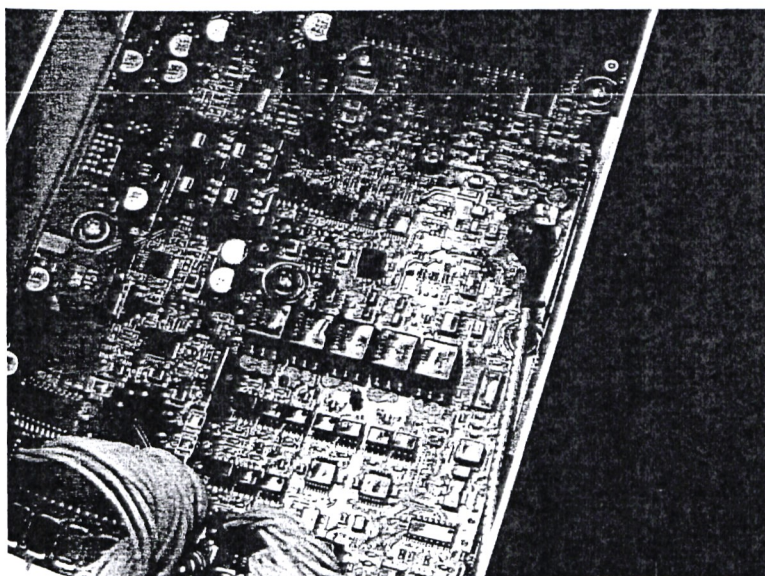
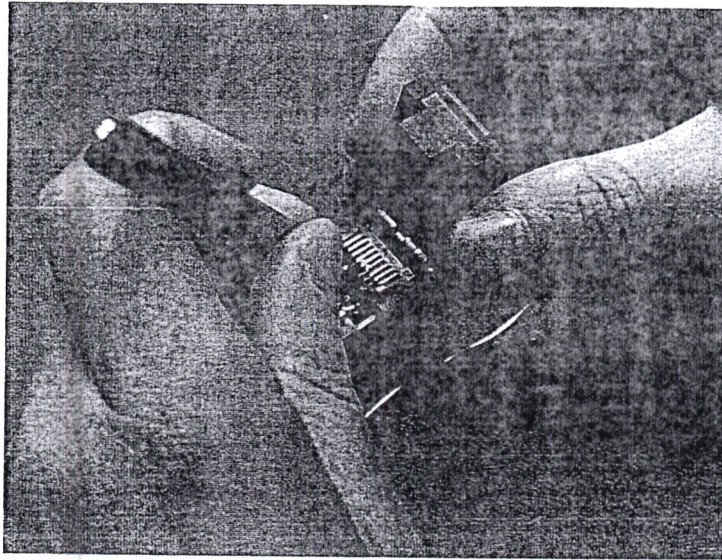
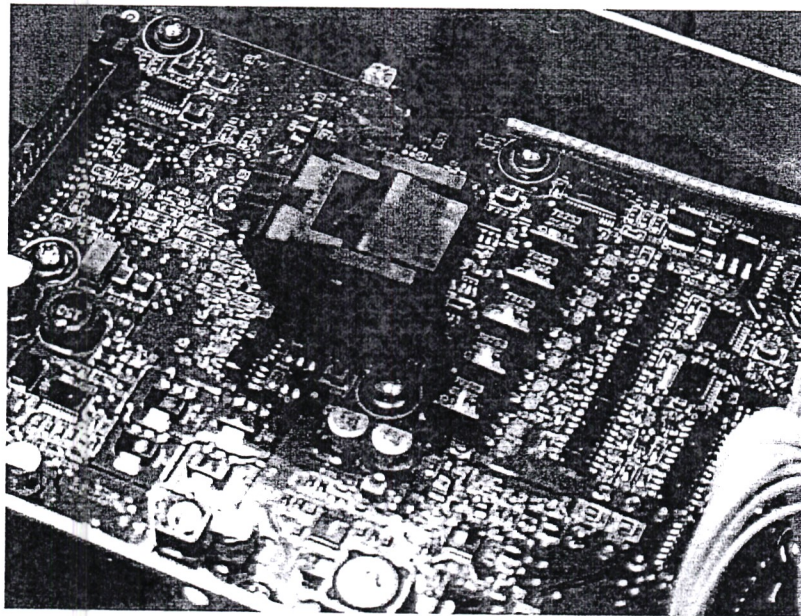
As the leads of the recovered flash were charred, the IC was soaked in isopropyl alcohol in an attempt to prepare them for soldering. After several unsuccessful attempts to solder the recovered flash to the new board, a Zero Insertion Force (ZIF) socket was used to connect the flash to the PCB.

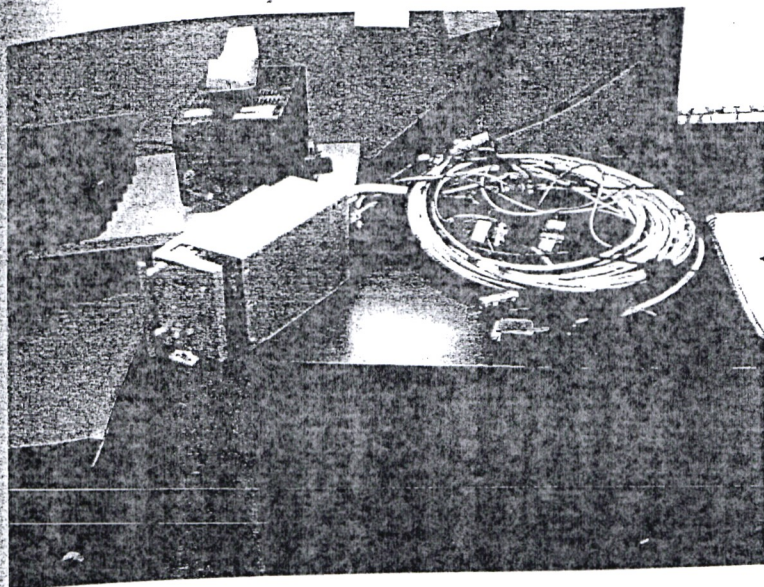
Figure 29: ISAT Log Recovery Setup

Power was then applied to the fully assembled ISAT as per the standard procedure, however upon receipt of multiple 'Serial Flash Failed' debug messages the extraction was terminated.

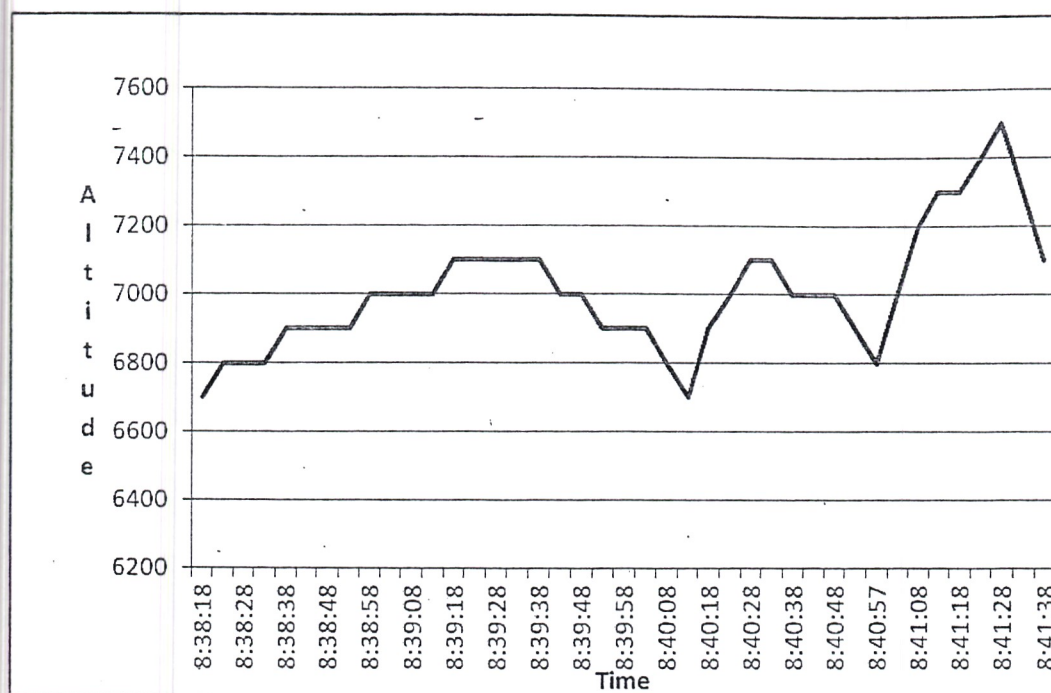
**Figure 36: Altitude variance final sector of the flight**

The helicopter was also fitted with the Skytrac flight following system that uses satellite based navigation for flight tracking. Skytrac system data corroborated the radar data in the reconstruction of the flight path.

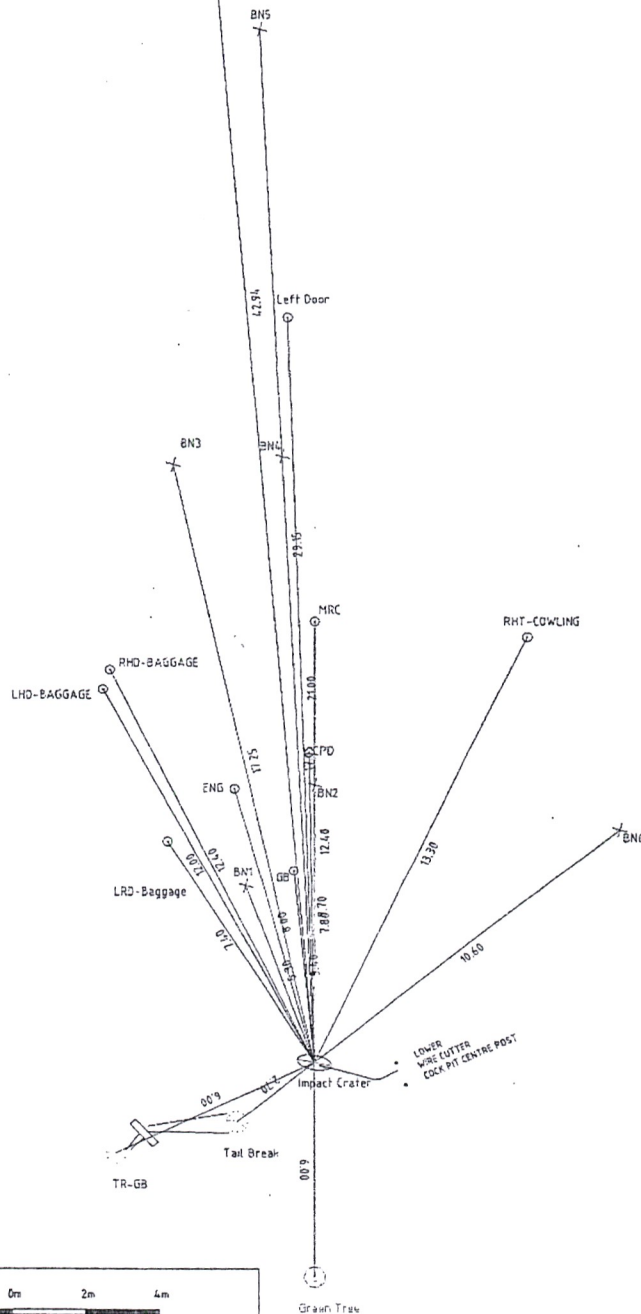
5Y-CDT WRECKAGE DISTRIBUTION:  
KIBIKO, NGONG  
IMPACT POSITION: S 1° 19.73' E 36° 38.29'
